# Earl Boyles Elementary

David Douglas SD 40

## FEMA 154 Rapid Visual Screening Score Card

Rapid Visual Screening - Senate Bill #2 - Seismic Needs Assessment  
Oregon Department of Geology and Mineral Industries

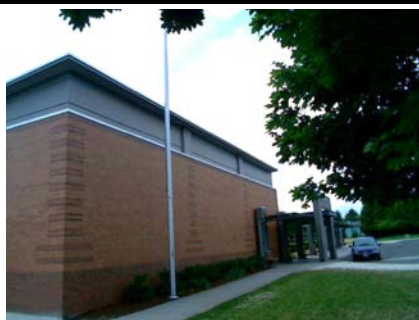
NE Primary Structural Type  
NEW BRICK COVERS OLD CONC STRUCTURE

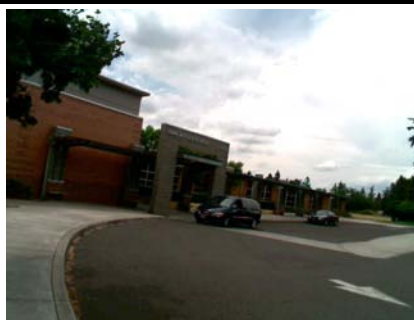
NE Plan Irregularity Primary  
NEW FRONT CANOPY

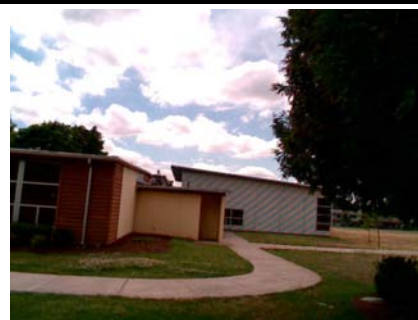
NW Plan Irregularity Tertiary  
CONN TO NEW SECTION

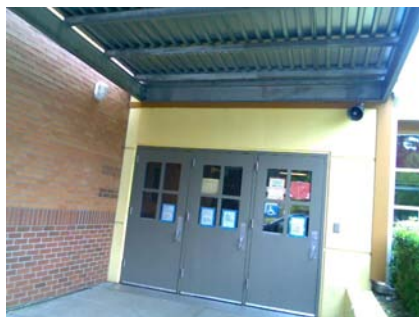
N Other  
SECURE CANOPIES

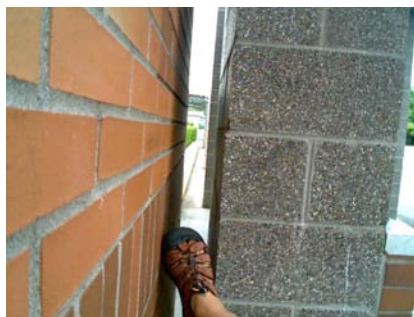
N Building Quality  
NO POUNDING

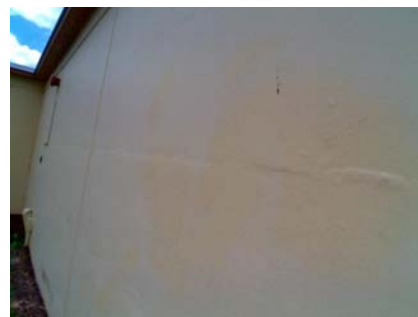
E Other  
FORM MARKS IN OLD CONC WALL

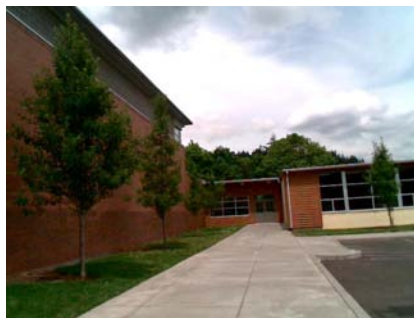
S Elevation View  
CONN TO NEW SECTION
