Dallas Police Department

Polk_pol02A

FEMA 154 Rapid Visual Screening Score Card

Rapid Visual Screening - Senate Bill #2 - Seismic Needs Assessment
Oregon Department of Geology and Mineral Industries

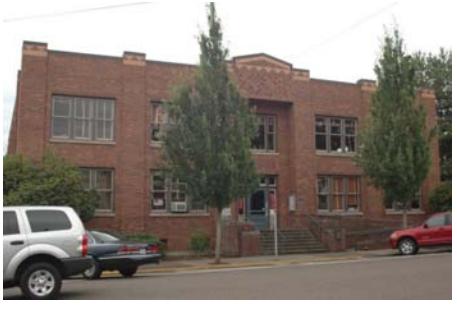
S Vertical Irregularity Primary This is the RM stair tower		E General Site
