Henry Hill Elementary School

Central SD 13J

FEMA 154 Rapid Visual Screening Score Card

Rapid Visual Screening - Senate Bill #2 - Seismic Needs Assessment
Oregon Department of Geology and Mineral Industries

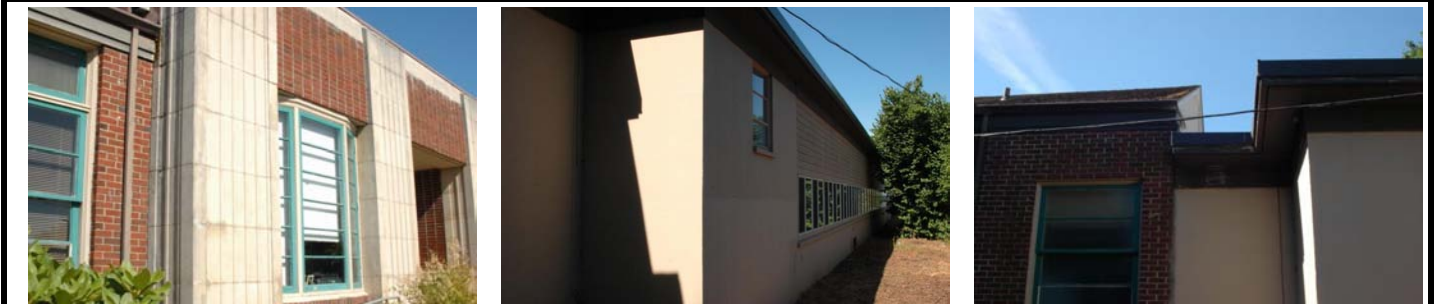
Plan Irregularities	Vertical Irregularities
Out of Plane Lateral-Force-Resistance Elements	Steps in Elevation View: Single Change (Adjacent Building/Entity)
Reentrant Corners: E Shaped	Steps in Elevation View: Single Change
Reentrant Corners: Other (Adjacent Build/Entity)	None

Falling Hazards	Poor Conditions
Parapets: Unreinforced Over Exit	None
None	None
None	None

E Plan Irregularity Primary

NE Plan Irregularity Primary

NE Vertical Irregularity Primary

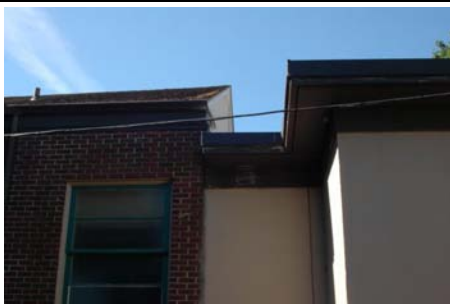
Plan Irregularities	Vertical Irregularities
Reentrant Corners: U shaped (Adjacent Build/Entity)	Steps in Elevation View: Single Change (Adjacent Building/Entity)
None	None
None	None

N Vertical Irregularity Primary

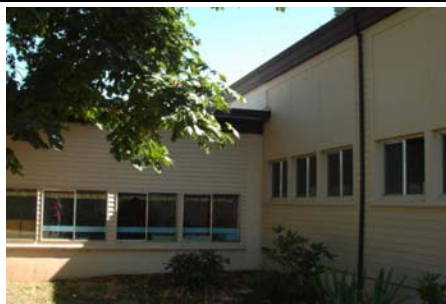
S Plan Irregularity Primary
step in elevation
