Whitworth Elementary School

Dallas SD 2

FEMA 154 Rapid Visual Screening Score Card

Rapid Visual Screening - Senate Bill #2 - Seismic Needs Assessment
Oregon Department of Geology and Mineral Industries

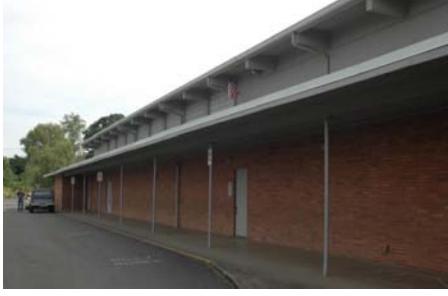
W General Site

Final Type	Final Score
W2	0.9

High (>10%)

Enrollment 450	Year Built (Field Verified) 1975	Year Built (Alt. Source) 1975	Est. Decade Built 1950
Total Area (square ft) 48748	Number of Stories 1	Basement	Pounding Potential Yes
Plan Irregularities Reentrant Corners: Other None None		Vertical Irregularities Steps in Elevation View: 2 to 3 Changes Steps in Elevation View: 2 to 3 Changes (Adjacent Building/Entity) None	
Falling Hazards None None None		Poor Conditions None None None

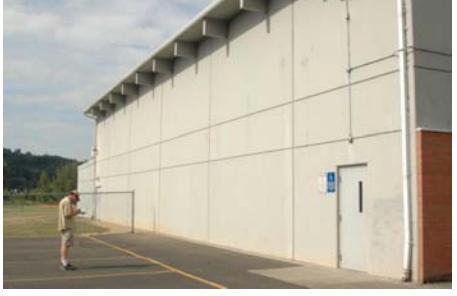
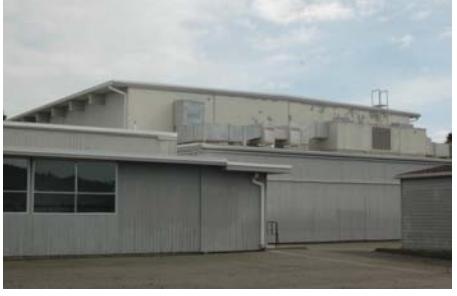
Final Type	Final Score
PC1	2.2

Low (<1%)

Enrollment 450	Year Built (Field Verified) 1975	Year Built (Alt. Source) 1975	Est. Decade Built 1990
Total Area (square ft) 48748	Number of Stories 1	Basement	Pounding Potential No
Plan Irregularities None None None		Vertical Irregularities Steps in Elevation View: Single Change None None	
Falling Hazards None None None		Poor Conditions None None None

NE Primary Structural Type		S Vertical Irregularity Primary

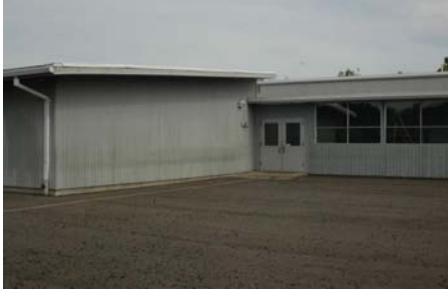
Final Type	Final Score
W2	0.9

High (>10%)

Enrollment 450	Year Built (Field Verified) 1975	Year Built (Alt. Source) 1975	Est. Decade Built 1970
Total Area (square ft) 48748	Number of Stories 1	Basement	Pounding Potential No
Plan Irregularities		Vertical Irregularities	
Reentrant Corners: Other		Steps in Elevation View: Very Irregular Changes	
Non-Parallel System		Steps in Elevation View: Single Change (Adjacent Building/Entity)	
None		None	
Falling Hazards		Poor Conditions	
None		None	
None		None	
None		None

SE Plan Irregularity Primary
