Sherman County Sheriff Courthouse

Sher_pol01A

FEMA 154 Rapid Visual Screening Score Card

Rapid Visual Screening - Senate Bill #2 - Seismic Needs Assessment
Oregon Department of Geology and Mineral Industries

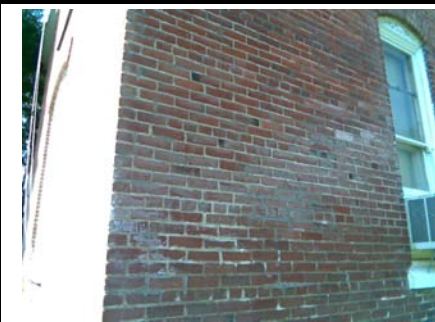
E Primary Structural Type

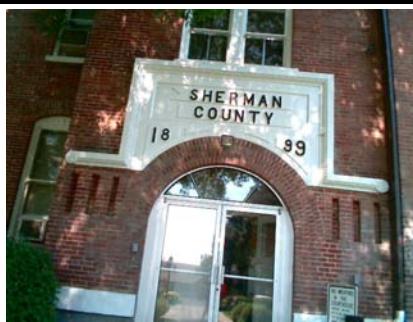
S Field Verified Year Built

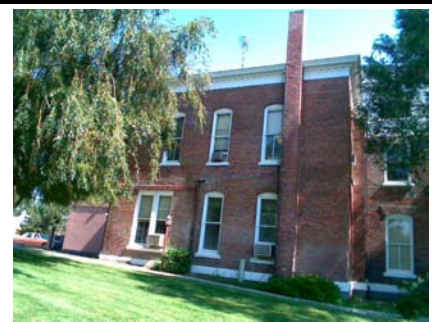
Falling Hazards	Poor Conditions
Unreinforced Chimneys	None
None	None
None	None

W Falling Hazard

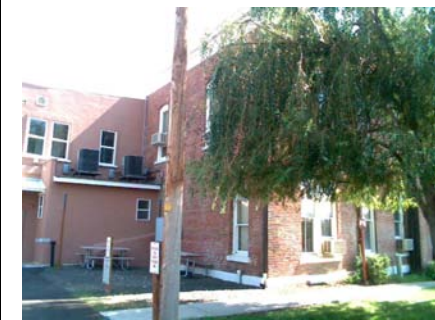
NW General Site
CONN TO B

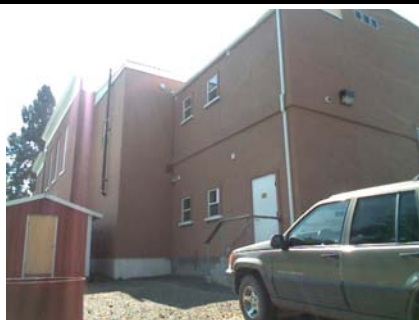
Plan Irregularities	Vertical Irregularities
Reentrant Corners: Other	Steps in Elevation View: 2 to 3 Changes
Reentrant Corners: Other (Adjacent Build/Entity)	Steps in Elevation View: 2 to 3 Changes (Adjacent Building/Entity)
None	None

NE Plan Irregularity Primary
