Sherman Junior/Senior High School

Sherman County SD

FEMA 154 Rapid Visual Screening Score Card

Rapid Visual Screening - Senate Bill #2 - Seismic Needs Assessment
Oregon Department of Geology and Mineral Industries

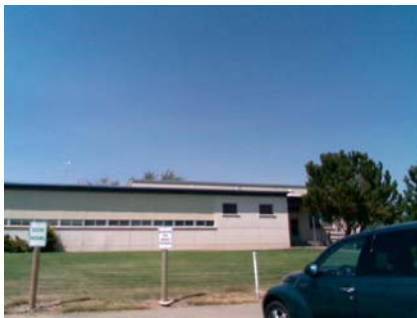
S Vertical Irregularity Primary

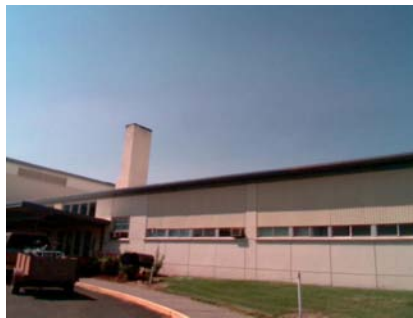
S Falling Hazard

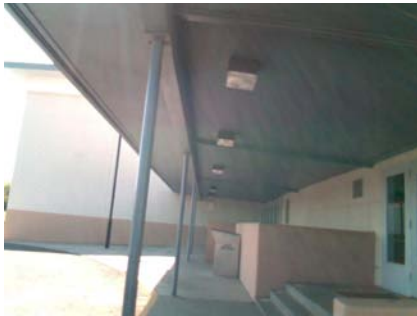
S Falling Hazard

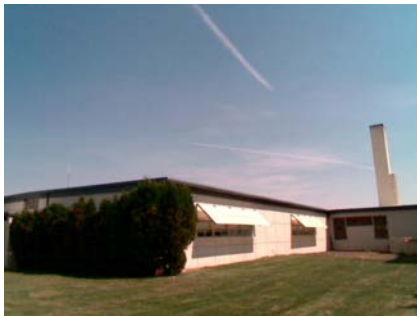
NW Plan Irregularity Primary

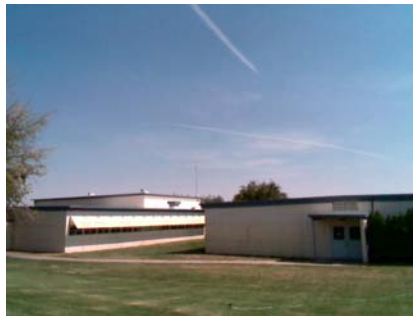
NW Vertical Irregularity Primary

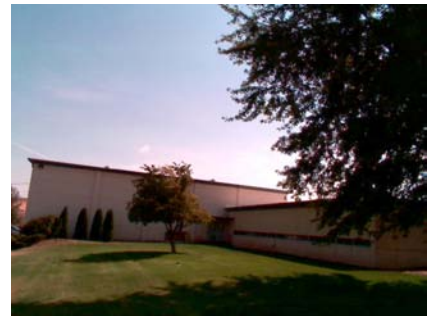
NE Plan Irregularity Primary
WING E HAS FEW N-S SHEAR WALLS

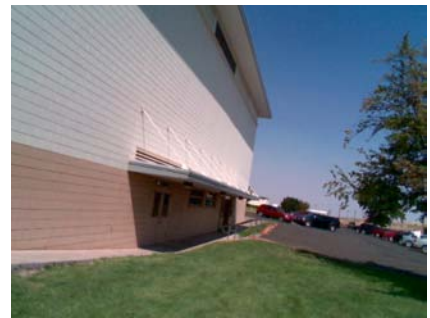
S Falling Hazard

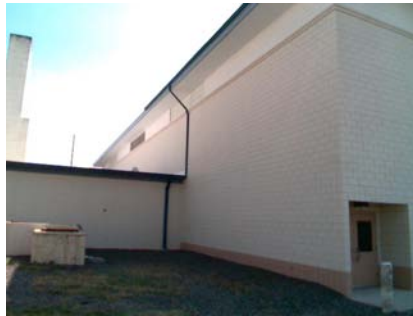
NE Plan Irregularity Primary

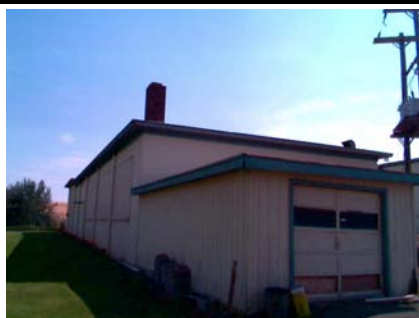
NE Falling Hazard
