# Bay City Fire Department

Till\_fir02A

## FEMA 154 Rapid Visual Screening Score Card

Rapid Visual Screening - Senate Bill #2 - Seismic Needs Assessment  
Oregon Department of Geology and Mineral Industries

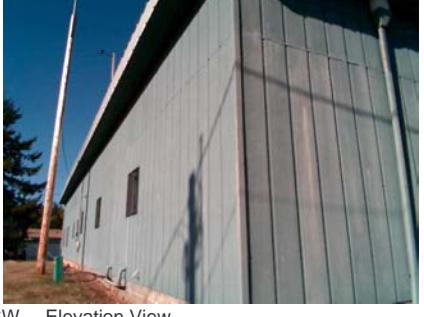
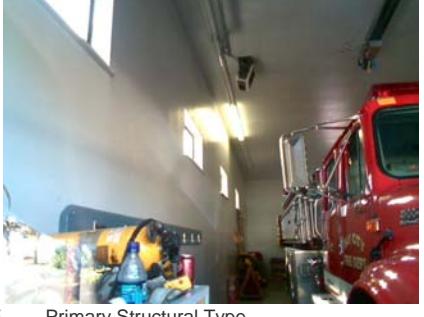
SW Elevation View CMU FDN		E Primary Structural Type WOOD FRAMED W/ SHEETROCK
