# Netarts-Oceanside RFPD Station #61 Hall

Till\_fir03A

## FEMA 154 Rapid Visual Screening Score Card

Rapid Visual Screening - Senate Bill #2 - Seismic Needs Assessment  
Oregon Department of Geology and Mineral Industries

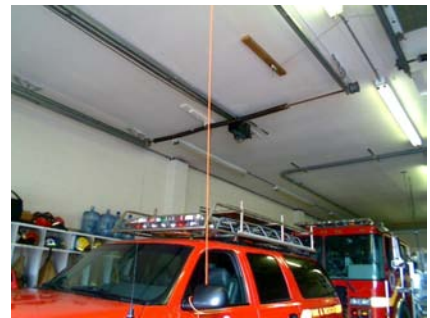
N Primary Structural Type  
PILASTERS

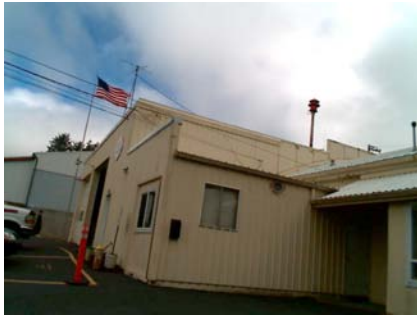
| Reentrant Corners: Other (Adjacent Build/Entity) | Steps in Elevation View: 2 to 3 Changes (Adjacent Building/Entity) |

SW Vertical Irregularity Primary
