# Nestucca RFPD

Till\_fir04A

Rapid Visual Screening - Senate Bill #2 - Seismic Needs Assessment  
Oregon Department of Geology and Mineral Industries

Till\_fir04B

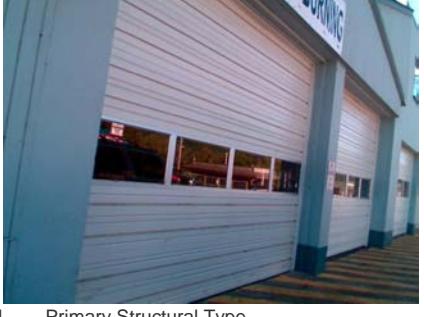
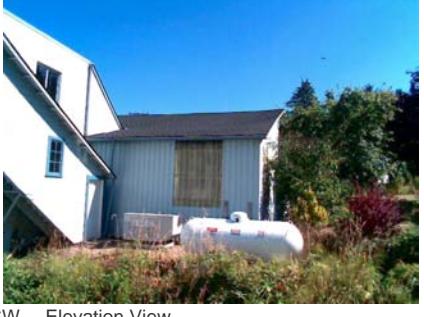
Very High (100%)

Enrollment	Year Built (Field Verified)	Year Built (Alt. Source)	Est. Decade Built
		1900	1930
Total Area (square ft)	Number of Stories	Basement	Pounding Potential
	1	No	Yes
Plan Irregularities		Vertical Irregularities	
Torsion: Eccentric Stiffness		Steps in Elevation View: Single Change (Adjacent Building/Entity)	
None		None	
None		None	
Falling Hazards		Poor Conditions	
None		None	
None		None	
None		None

N Primary Structural Type CONC FRAMES - THIS BLDG WAS ORIGINALLY A GARAGE		SW Elevation View LOOKS LIKE A WOOD FRAMED ADDN IN BACK - NOT ACCESSIBLE

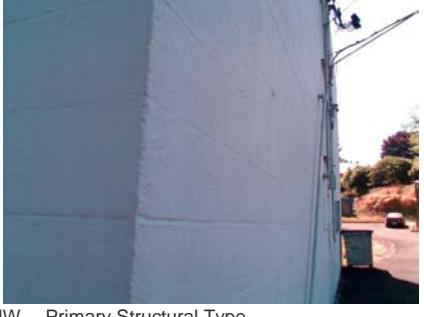
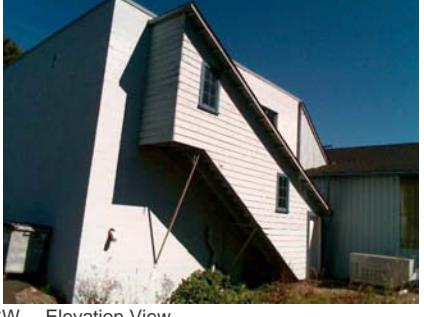
NW Primary Structural Type		SW Elevation View

High (>10%)

Enrollment	Year Built (Field Verified)	Year Built (Alt. Source)	Est. Decade Built
		1900	1960
Total Area (square ft)	Number of Stories	Basement	Pounding Potential
	1	No	Yes
Plan Irregularities		Vertical Irregularities	
Torsion: Eccentric Stiffness		Steps in Elevation View: Single Change (Adjacent Building/Entity)	
None		None	
None		None	
Falling Hazards		Poor Conditions	
None		None	
None		None	
None		None
