City Of Garibaldi Fire Department / City Hall / Police

Till_fir05A

FEMA 154 Rapid Visual Screening Score Card

Rapid Visual Screening - Senate Bill #2 - Seismic Needs Assessment
Oregon Department of Geology and Mineral Industries

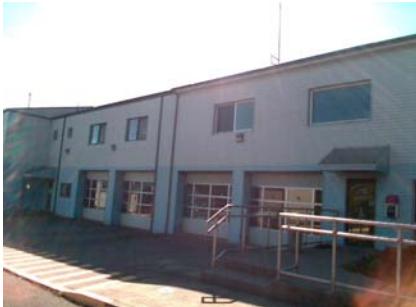
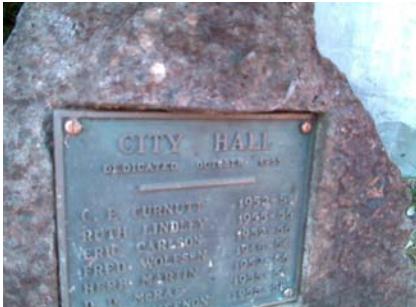
E	Elevation View	E	Field Verified Year Built DEDICATED 1955

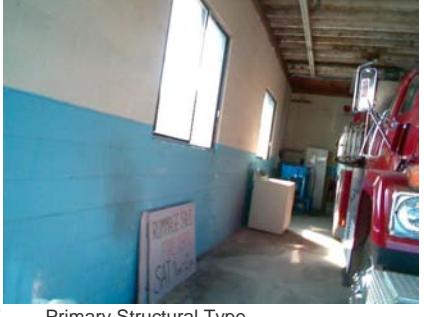
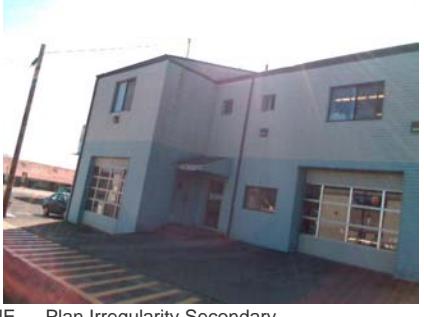
E	Primary Structural Type	NE	Plan Irregularity Secondary
