Nestucca RFPD

## FEMA 154 Rapid Visual Screening Score Card

Nestucca RFPD Pacific City #82

Rapid Visual Screening - Senate Bill #2 - Seismic Needs Assessment  
Oregon Department of Geology and Mineral Industries

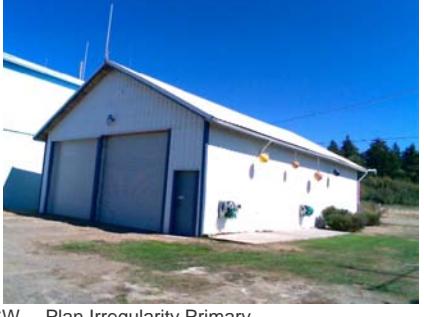
| NE | Primary Structural Type | SW | Plan Irregularity Primary |

| Torsion: Eccentric Stiffness | | None | |
