# Nestucca RFPD Sandlake #85

Till\_fir12A

## FEMA 154 Rapid Visual Screening Score Card

Rapid Visual Screening - Senate Bill #2 - Seismic Needs Assessment  
Oregon Department of Geology and Mineral Industries

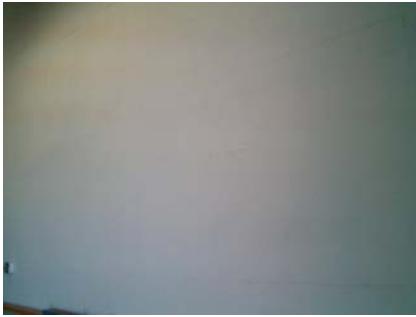
S Primary Structural Type PLYWOOD PANELS ON INSIDE OF WALLS IN GARAGE
