Nestucca RFPD

FEMA 154 Rapid Visual Screening Score Card

Nestucca RFPD Beaver #83

Rapid Visual Screening - Senate Bill #2 - Seismic Needs Assessment
Oregon Department of Geology and Mineral Industries

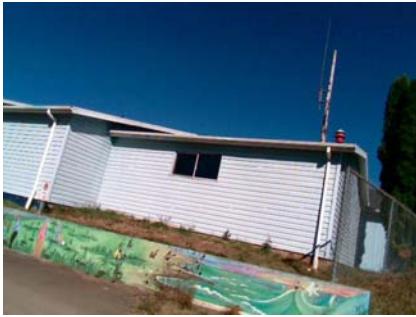
SW Plan Irregularity Primary

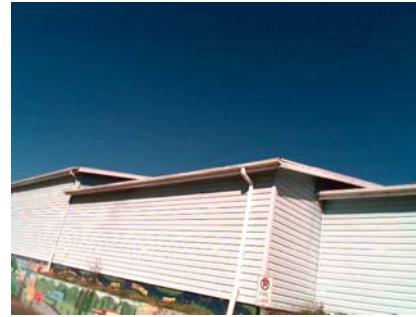
SW Vertical Irregularity Primary

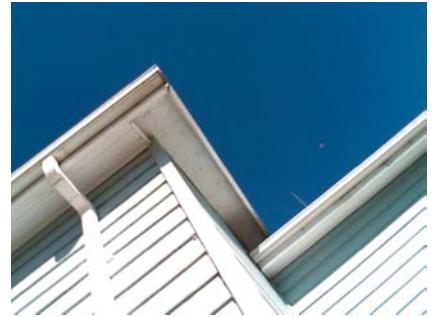
W Primary Structural Type OSB SHEATHING

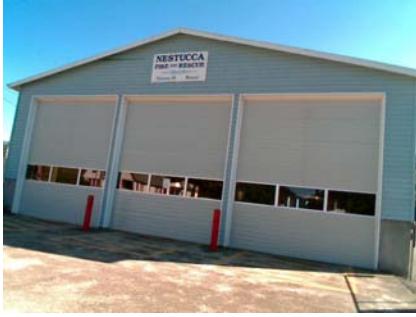
N Plan Irregularity Secondary

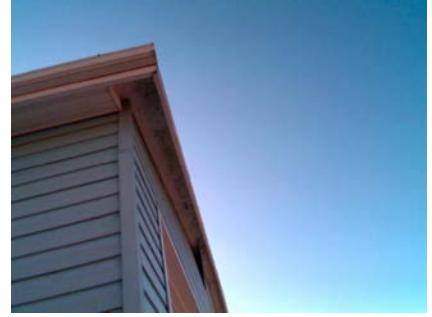
N Primary Structural Type OSB SHEATHING

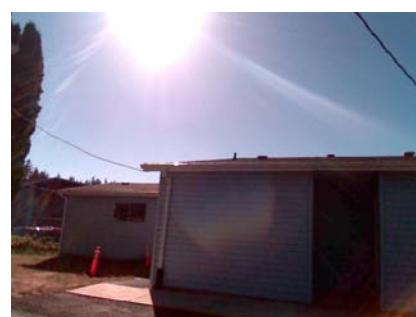
E Plan Irregularity Primary
