Liberty Elementary School

Tillamook SD 9

FEMA 154 Rapid Visual Screening Score Card

Rapid Visual Screening - Senate Bill #2 - Seismic Needs Assessment
Oregon Department of Geology and Mineral Industries

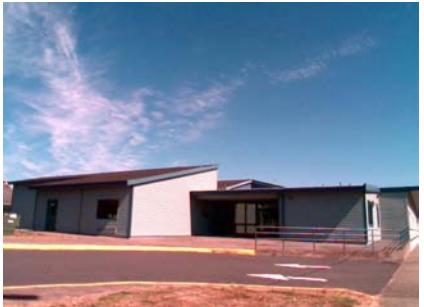
SW Plan Irregularity Primary		SW Elevation View

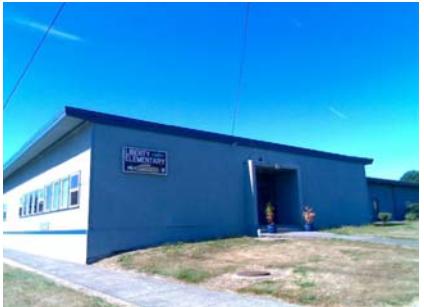
SE Primary Structural Type STUCCO END WALL

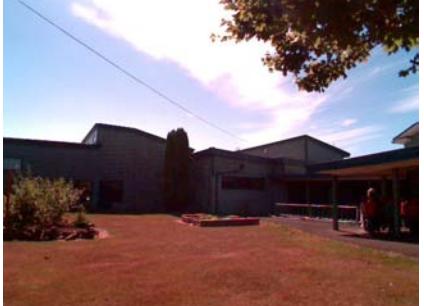
N Vertical Irregularity Primary		NW Vertical Irregularity Secondary

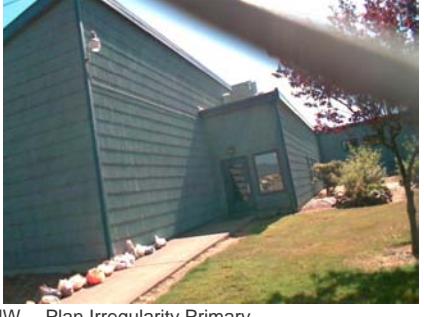
NW Plan Irregularity Primary		NW Vertical Irregularity Secondary
