Good Shepherd Community Hospital - Hermiston

Umat_hos01A

FEMA 154 Rapid Visual Screening Score Card

Rapid Visual Screening - Senate Bill #2 - Seismic Needs Assessment
Oregon Department of Geology and Mineral Industries

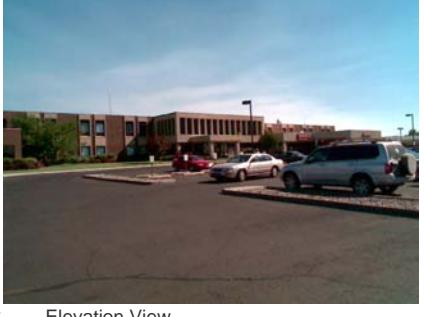
Enrollment	Year Built (Field Verified)	Year Built (Alt. Source)	Est. Decade Built
		1985	1970
Total Area (square ft)	Number of Stories	Basement	Pounding Potential
158577	2	No	No
Plan Irregularities		Vertical Irregularities	
Reentrant Corners: Other		Steps in Elevation View: Single Change	
None		Steps in Elevation View: Single Change (Adjacent Building/Entity)	
None		None	
Falling Hazards		Poor Conditions	
None		None	
None		None	
None		None

S	Elevation View	N	Elevation View

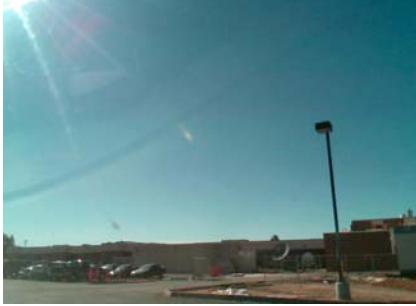
Enrollment	Year Built (Field Verified)	Year Built (Alt. Source)	Est. Decade Built
		1985	1980
Total Area (square ft)	Number of Stories	Basement	Pounding Potential
158577	1	No	No
Plan Irregularities		Vertical Irregularities	
Reentrant Corners: Other		Steps in Elevation View: Single Change (Adjacent Building/Entity)	
None		None	
None		None	
Falling Hazards		Poor Conditions	
None		None	
None		None	
None		None

N	Elevation View	W	Elevation View

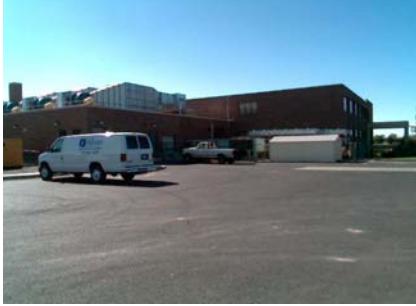
NE Elevation View

Enrollment	Year Built (Field Verified)	Year Built (Alt. Source)	Est. Decade Built
		1985	1990
Total Area (square ft)	Number of Stories	Basement	Pounding Potential
158577	2	No	No
Plan Irregularities		Vertical Irregularities	
Reentrant Corners: T shaped		Steps in Elevation View: Single Change	
None		None	
None		None	
Falling Hazards		Poor Conditions	
None		None	
None		None	
None		None
