Ferndale Elementary School

Umat_sch09A

FEMA 154 Rapid Visual Screening Score Card

Rapid Visual Screening - Senate Bill #2 - Seismic Needs Assessment
Oregon Department of Geology and Mineral Industries

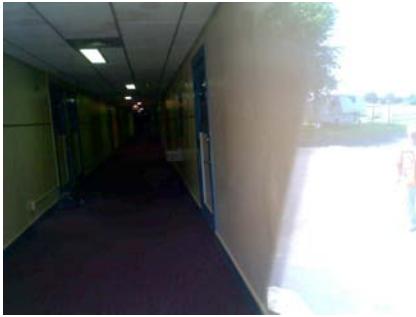
S Tertiary Structural Type looks like dry wall, indicating w2

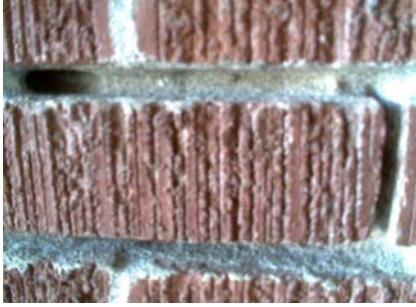
N Poor Condition veneer in poor condition

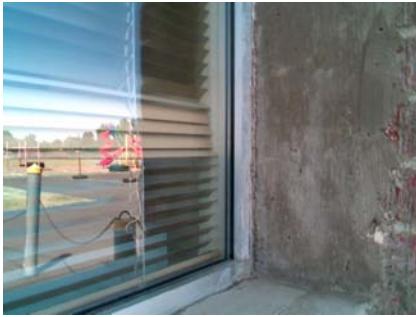
S Primary Structural Type c2 indication but a cover layer of stucco occurs, could be rm1 or urm underneath

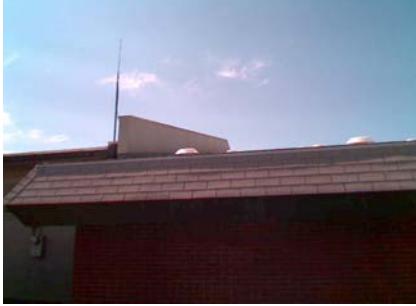
E Vertical Irregularity Primary
