Sherwood Heights Elementary School

Pendleton SD 16

Umat_sch10A

Rapid Visual Screening - Senate Bill #2 - Seismic Needs Assessment
Oregon Department of Geology and Mineral Industries

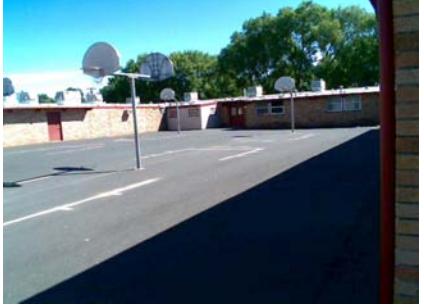
Enrollment 373	Year Built (Field Verified) 1960	Year Built (Alt. Source) 1950	Est. Decade Built
Total Area (square ft) 37581	Number of Stories 1	Basement	Pounding Potential No
Plan Irregularities		Vertical Irregularities	
Reentrant Corners: Other		Steps in Elevation View: 2 to 3 Changes (Adjacent Building/Entity)	
Reentrant Corners: U shaped		None	
None		None	
Falling Hazards		Poor Conditions	
None		None	
None		None	
None		None

W Plan Irregularity Primary

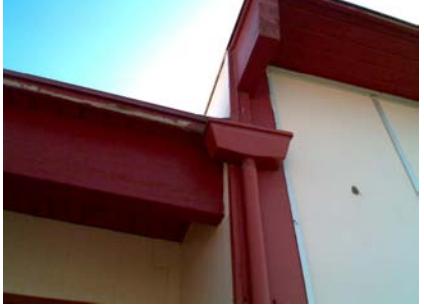
Enrollment 373	Year Built (Field Verified) 1960	Year Built (Alt. Source) 1960	Est. Decade Built 1950
Total Area (square ft)	Number of Stories 1	Basement	Pounding Potential No
Plan Irregularities Reentrant Corners:U shaped (Adjacent Build/Entity) None None		Vertical Irregularities Steps in Elevation View: 2 to 3 Changes (Adjacent Building/Entity) None None	
Falling Hazards None None None		Poor Conditions None None None

N Vertical Irregularity Primary

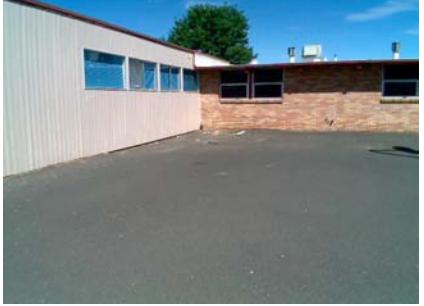
W Plan Irregularity Primary

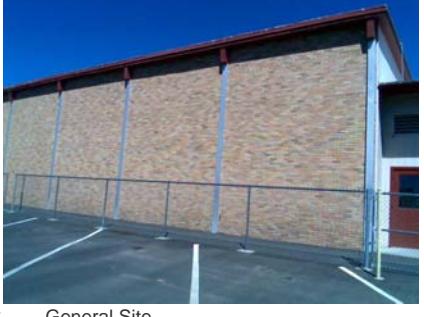
S General Site

Enrollment 373	Year Built (Field Verified) 1960	Year Built (Alt. Source) 1960	Est. Decade Built 1970
Total Area (square ft)	Number of Stories 1	Basement	Pounding Potential No
Plan Irregularities Reentrant Corners:L shaped (Adjacent Build/Entity) None None		Vertical Irregularities Steps in Elevation View: Single Change (Adjacent Building/Entity) None None	
Falling Hazards None None None		Poor Conditions None None None

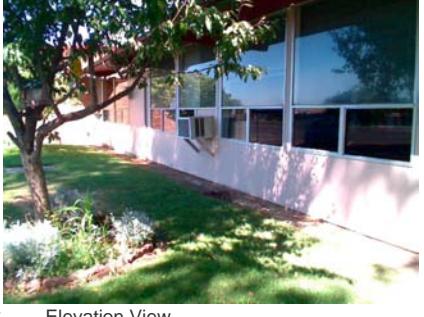
S Elevation View

Enrollment 373	Year Built (Field Verified) 1960	Year Built (Alt. Source) 1960	Est. Decade Built 1970
Total Area (square ft)	Number of Stories 1	Basement	Pounding Potential No
Plan Irregularities Reentrant Corners:Other (Adjacent Build/Entity) None None		Vertical Irregularities Steps in Elevation View: Single Change (Adjacent Building/Entity) None None	
Falling Hazards None None None		Poor Conditions None None None

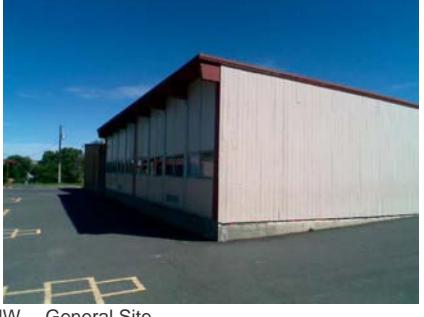
NW General Site

Enrollment 373	Year Built (Field Verified) 1960	Year Built (Alt. Source) 1960	Est. Decade Built 1980
Total Area (square ft)	Number of Stories 1	Basement	Pounding Potential No
Plan Irregularities Reentrant Corners:L shaped (Adjacent Build/Entity) None None		Vertical Irregularities Steps in Elevation View: Single Change Steps in Elevation View: Single Change (Adjacent Building/Entity) None	
Falling Hazards None None None		Poor Conditions None None None
