# Freewater Elementary School

Umat\_sch15A

## FEMA 154 Rapid Visual Screening Score Card

Rapid Visual Screening - Senate Bill #2 - Seismic Needs Assessment  
Oregon Department of Geology and Mineral Industries

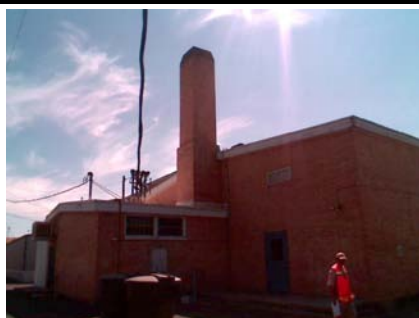
Falling Hazards	Poor Conditions
Other: Smokestack	None
None	None
None	None

NE Falling Hazard
