Grove Elementary School

Milton-Freewater Unified SD 7

FEMA 154 Rapid Visual Screening Score Card

Rapid Visual Screening - Senate Bill #2 - Seismic Needs Assessment
Oregon Department of Geology and Mineral Industries

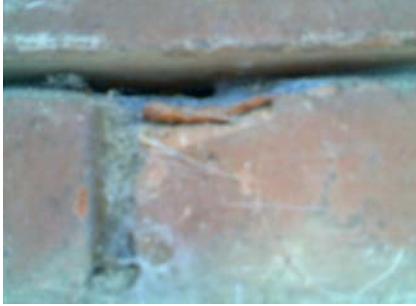
Enrollment 370	Year Built (Field Verified) 1915	Year Built (Alt. Source) 1915	Est. Decade Built 1900
Total Area (square ft) 27737	Number of Stories 2	Basement	Pounding Potential Yes
Plan Irregularities Reentrant Corners:L shaped (Adjacent Build/Entity) None None		Vertical Irregularities Steps in Elevation View: Single Change (Adjacent Building/Entity) None None	
Falling Hazards None None None		Poor Conditions Poor Masonry None None

W Poor Condition

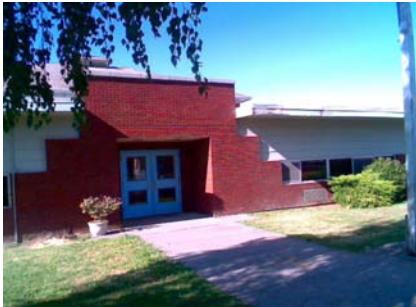
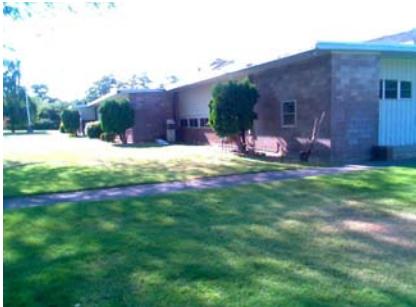
Enrollment 370	Year Built (Field Verified) 1984	Year Built (Alt. Source) 1915	Est. Decade Built 1980
Total Area (square ft) 27737	Number of Stories 1	Basement	Pounding Potential No
Plan Irregularities		Vertical Irregularities	
Reentrant Corners: Other		Steps in Elevation View: Single Change	
Reentrant Corners: L Shaped		None	
None		None	
Falling Hazards		Poor Conditions	
None		None	
None		None	
None		None

S Elevation View		SE Plan Irregularity Primary

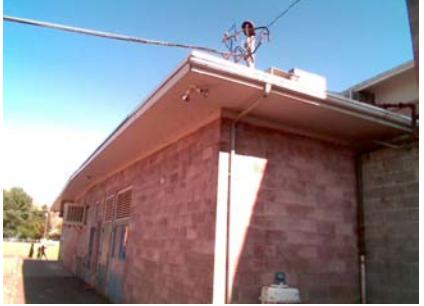
Enrollment 370	Year Built (Field Verified) 1915	Year Built (Alt. Source) 1915	Est. Decade Built 1960
Total Area (square ft) 27737	Number of Stories 1	Basement	Pounding Potential No
Plan Irregularities Reentrant Corners:Other (Adjacent Build/Entity)		Vertical Irregularities Steps in Elevation View: 2 to 3 Changes	
Reentrant Corners: Other None		Steps in Elevation View: Single Change (Adjacent Building/Entity) None	
Falling Hazards None		Poor Conditions None	
None		None	
None		None

N Vertical Irregularity Primary
