Helix School

Umat_sch29A

FEMA 154 Rapid Visual Screening Score Card

Rapid Visual Screening - Senate Bill #2 - Seismic Needs Assessment
Oregon Department of Geology and Mineral Industries

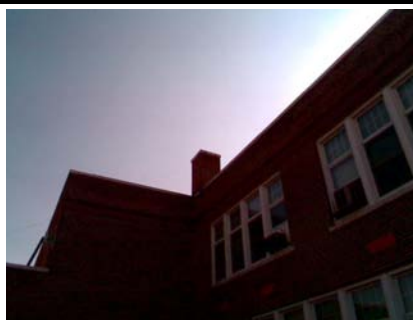
Falling Hazards	Poor Conditions
Parapets: Unreinforced Around Entire Building	None
Unreinforced Chimneys	None
None	None

E Falling Hazard

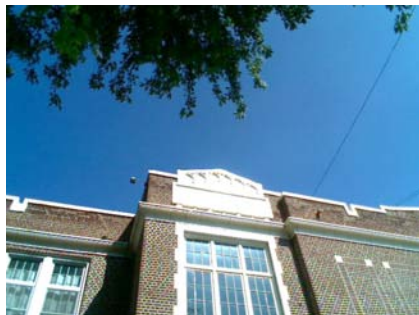
W Field Verified Year Built
1923
