Lincoln Primary School

Pendleton SD 16

FEMA 154 Rapid Visual Screening Score Card

Rapid Visual Screening - Senate Bill #2 - Seismic Needs Assessment
Oregon Department of Geology and Mineral Industries

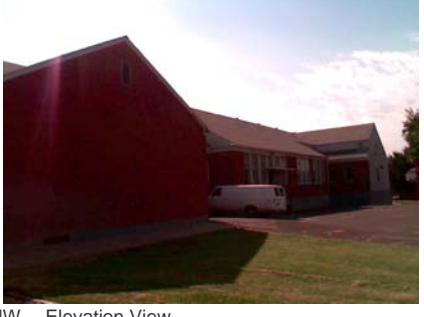
NW Elevation View		E Elevation View

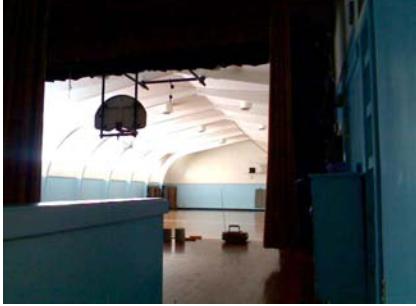
S Other		W Elevation View

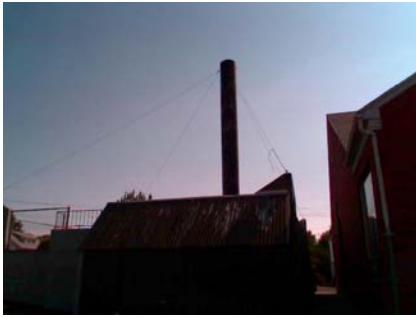
Enrollment 174	Year Built (Field Verified) 1948	Year Built (Alt. Source) 1948	Est. Decade Built 1980
Total Area (square ft)	Number of Stories 1	Basement	Pounding Potential No
Plan Irregularities Reentrant Corners:T shaped (Adjacent Build/Entity) None None		Vertical Irregularities None None None	
Falling Hazards Other: Smokestack None None		Poor Conditions None None None

W Falling Hazard adj. power building	E Elevation View
