Union High School

Unio_sch05A

Rapid Visual Screening - Senate Bill #2 - Seismic Needs Assessment
Oregon Department of Geology and Mineral Industries

Unio_sch05B

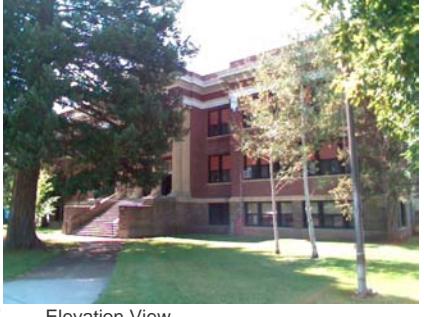
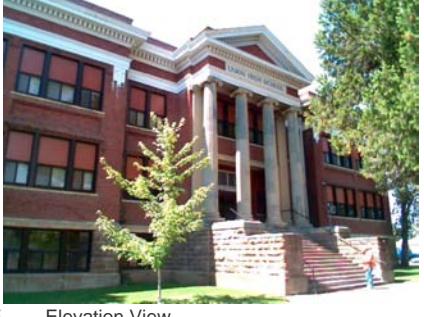
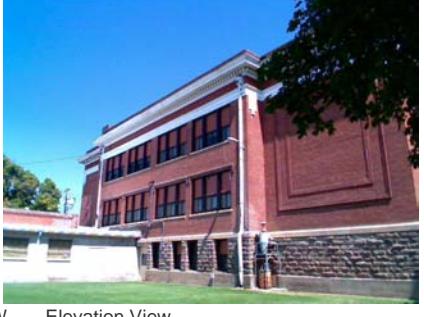
| | E Elevation View | | E Elevation View | | W Elevation View |

| Other: Ornamental Hazard Over Exit | | None | | | |
| Other: Heavy cornice or other overhead decoration | | None | | | |
| Parapets: Unreinforced Around Entire Building | | None | | | |

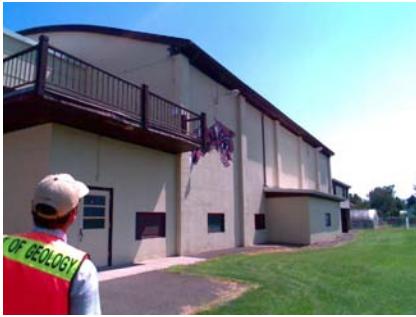
| W Elevation View | | N Falling Hazard | |

| Plan Irregularities Reentrant Corners: Other None None | | Vertical Irregularities Steps in Elevation View: Very Irregular Changes (Adjacent Building/Ent) None None | |

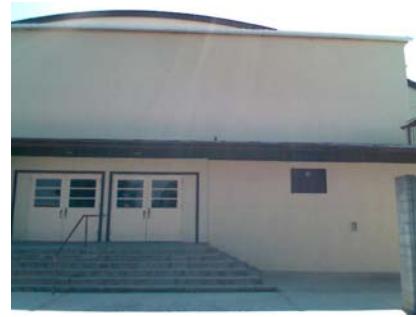
| Falling Hazards Other: Heavy cornice or other overhead decoration None None | | Poor Conditions None None None | |
