Imbler High School

FEMA 154 Rapid Visual Screening Score Card

Rapid Visual Screening - Senate Bill #2 - Seismic Needs Assessment
Oregon Department of Geology and Mineral Industries

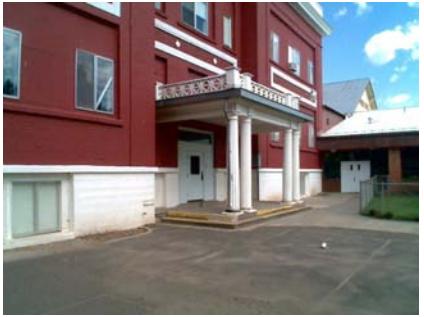
SE	Falling Hazard	S	Poor Condition

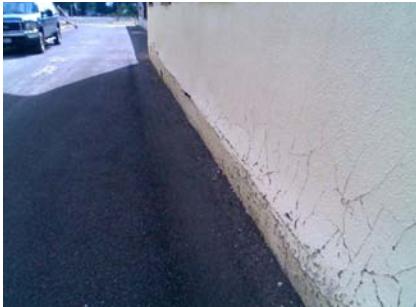
N Poor Condition stucco bubbling off
