# Stella Mayfield Elementary School

Unio\_sch08A

**FEMA 154 Rapid Visual Screening Score Card**

Rapid Visual Screening - Senate Bill #2 - Seismic Needs Assessment  
Oregon Department of Geology and Mineral Industries

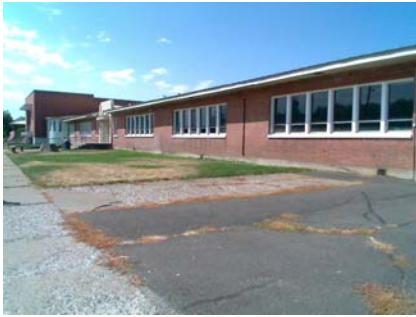
NE Elevation View

Enrollment 285	Year Built (Field Verified) 1947	Year Built (Alt. Source) 1940	Est. Decade Built 1940
Total Area (square ft) 45300	Number of Stories 1	Basement	Pounding Potential No
Plan Irregularities Reentrant Corners: L Shaped Reentrant Corners: Other None		Vertical Irregularities Steps in Elevation View: 2 to 3 Changes Steps in Elevation View: Single Change (Adjacent Building/Entity) None	
Falling Hazards None None None		Poor Conditions None None None

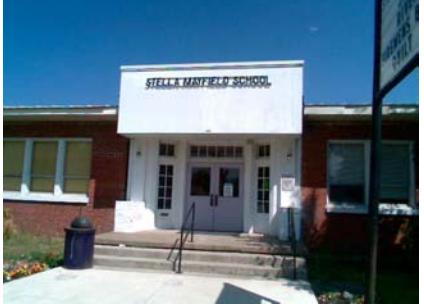
S Building Name

Enrollment 285	Year Built (Field Verified) 1947	Year Built (Alt. Source) 1947	Est. Decade Built 1950
Total Area (square ft) 45300	Number of Stories 1	Basement	Pounding Potential No
Plan Irregularities Reentrant Corners: U shaped Reentrant Corners: Other None		Vertical Irregularities Steps in Elevation View: Single Change (Adjacent Building/Entity) None None	
Falling Hazards None None None		Poor Conditions None None None

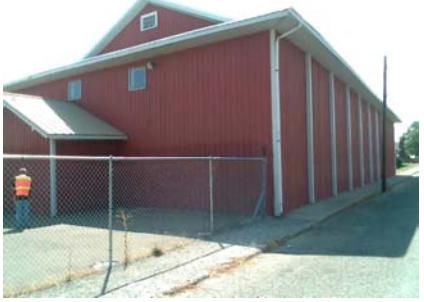
NW Elevation View

Enrollment 285	Year Built (Field Verified) 1947	Year Built (Alt. Source) 1947	Est. Decade Built 1960
Total Area (square ft) 45300	Number of Stories 1	Basement	Pounding Potential No
Plan Irregularities Reentrant Corners: T shaped Reentrant Corners: Other None		Vertical Irregularities Steps in Elevation View: Single Change Steps in Elevation View: Single Change (Adjacent Building/Entity) None	
Falling Hazards None None None		Poor Conditions None None None
