# Wallowa Elementary School

Wallowa SD 12

Wall\_sch02A

Rapid Visual Screening - Senate Bill #2 - Seismic Needs Assessment  
Oregon Department of Geology and Mineral Industries

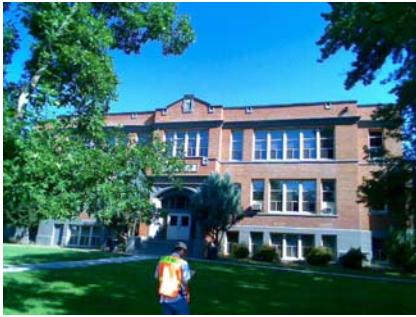
E Elevation View

Enrollment 143	Year Built (Field Verified) 1922	Year Built (Alt. Source) 1922	Est. Decade Built 1920
Total Area (square ft) 43098	Number of Stories 1	Basement	Pounding Potential No
Plan Irregularities		Vertical Irregularities	
Reentrant Corners: Other		Steps in Elevation View: Single Change	
Reentrant Corners: Other		Steps in Elevation View: Single Change (Adjacent Building/Entity)	
None		None	
Falling Hazards		Poor Conditions	
Parapets: Unreinforced Across Front of Building		None	
None		None	
None		None

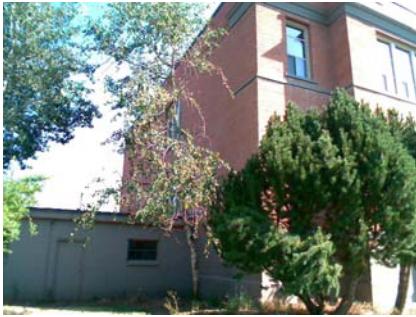
NE Vertical Irregularity Secondary

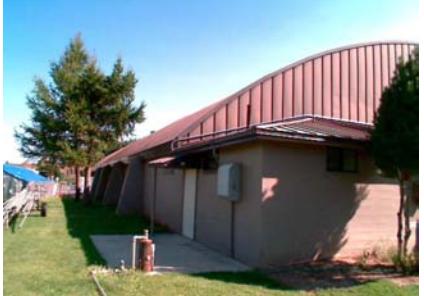
<p>N Elevation View</p>

Enrollment 143	Year Built (Field Verified) 1922	Year Built (Alt. Source) 1940	Est. Decade Built 1940
Total Area (square ft) 43098	Number of Stories 1	Basement	Pounding Potential No
Plan Irregularities Reentrant Corners: Other Reentrant Corners: Other None		Vertical Irregularities Steps in Elevation View: 2 to 3 Changes Steps in Elevation View: Single Change (Adjacent Building/Entity) None	
Falling Hazards None None None		Poor Conditions None None None

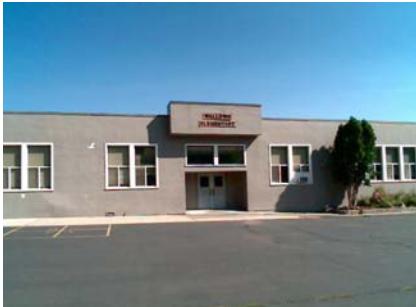
E Elevation View

Enrollment 143	Year Built (Field Verified) 1922	Year Built (Alt. Source) 1922	Est. Decade Built 1940
Total Area (square ft) 43098	Number of Stories 1	Basement	Pounding Potential No
Plan Irregularities Reentrant Corners:L shaped (Adjacent Build/Entity) None None		Vertical Irregularities Steps in Elevation View: Single Change (Adjacent Building/Entity) None None	
Falling Hazards None None None		Poor Conditions None None None

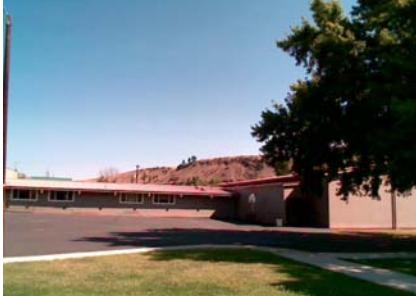
<p>E Elevation View</p>

Enrollment 143	Year Built (Field Verified) 1922	Year Built (Alt. Source) 1950	Est. Decade Built
Total Area (square ft) 43098	Number of Stories 1	Basement	Pounding Potential No
Plan Irregularities Reentrant Corners: L Shaped Reentrant Corners: L Shaped None		Vertical Irregularities Steps in Elevation View: Single Change Steps in Elevation View: Single Change (Adjacent Building/Entity) None	
Falling Hazards None None None		Poor Conditions None None None
