Enterprise High School

Wall_sch04A

FEMA 154 Rapid Visual Screening Score Card

Rapid Visual Screening - Senate Bill #2 - Seismic Needs Assessment
Oregon Department of Geology and Mineral Industries

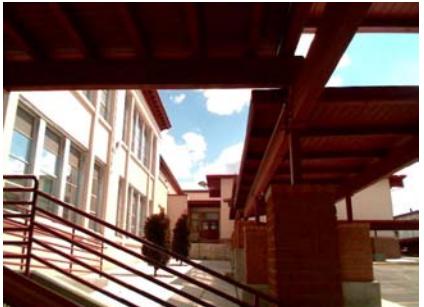
N Plan Irregularity Primary

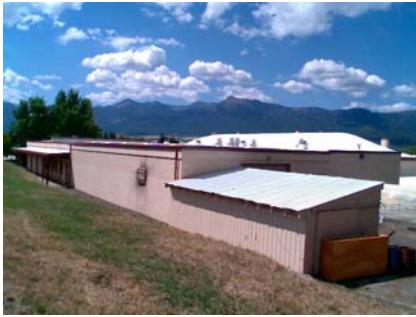
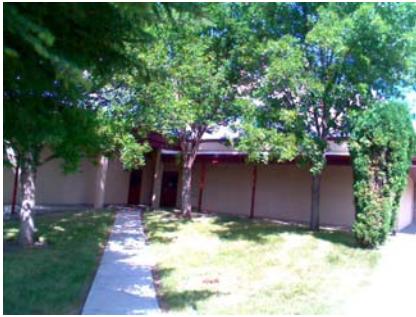
SE Elevation View		SW Plan Irregularity Secondary

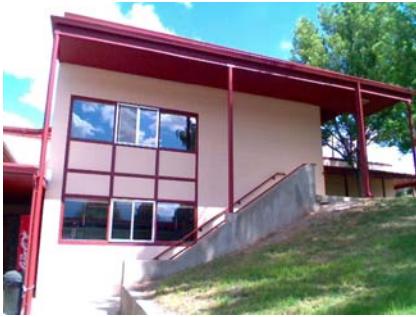
W Vertical Irregularity Secondary
