Dufur School

Wasc_sch06A

FEMA 154 Rapid Visual Screening Score Card

Rapid Visual Screening - Senate Bill #2 - Seismic Needs Assessment
Oregon Department of Geology and Mineral Industries

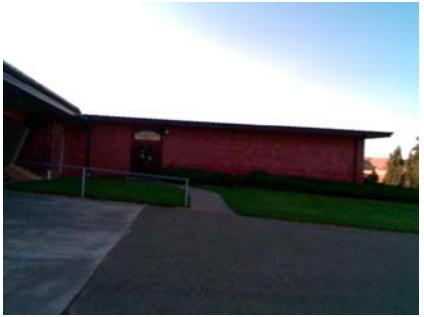
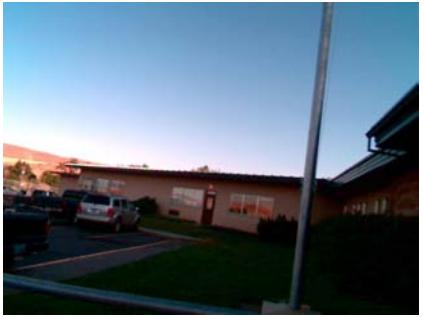
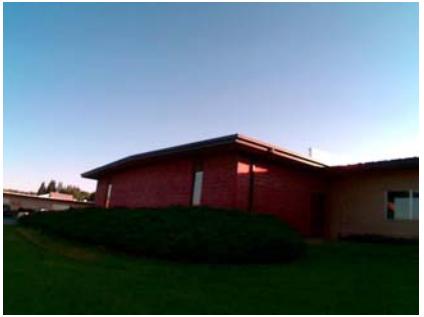
N Elevation View library addn	SW Elevation View n wing with wood add-on in front	SW Elevation View library addn and wood add-on in front of s wing

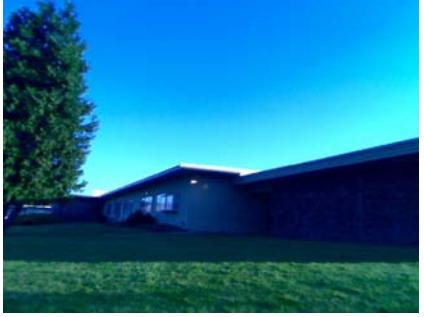
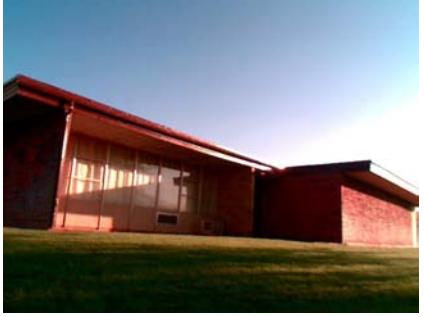
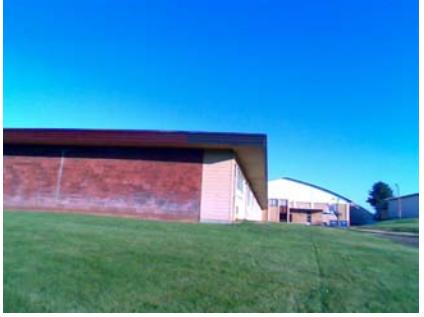
S Elevation View s wing	S Elevation View end of s wing	S Elevation View s wing to gym

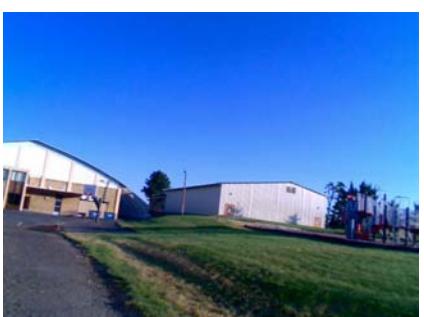
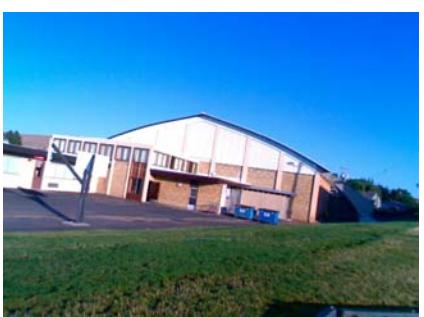
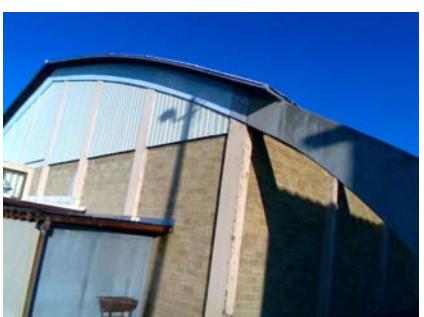
S General Site 1997 gym not screened	SE Vertical Irregularity Primary	SE Primary Structural Type 3 hinged arches and butresses

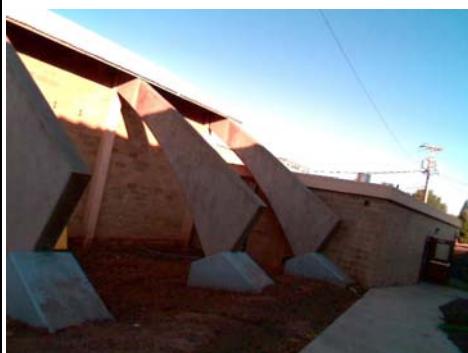
SE Plan Irregularity Primary

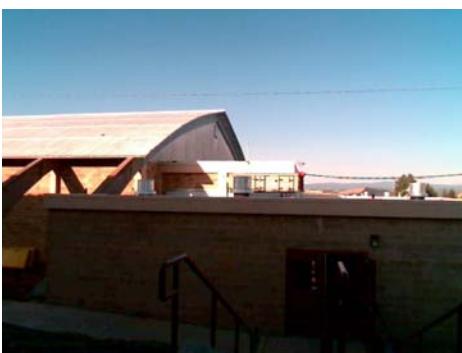
E Vertical Irregularity Primary

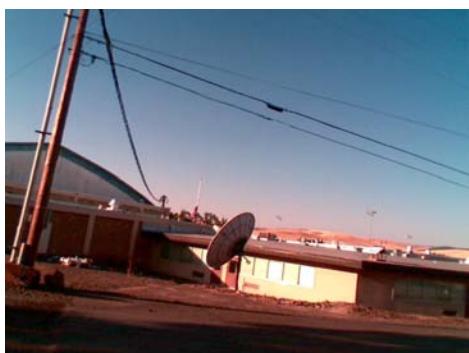
N Vertical Irregularity Primary

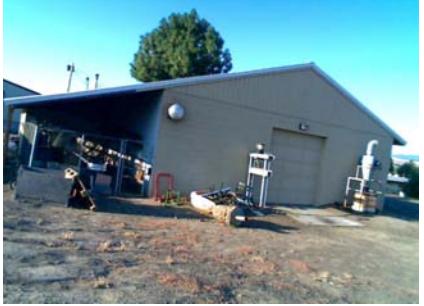
NW Elevation View
S Building Quality lean-to addn poor masonry
