TVF & R - Station 68 Oak Hills (House)

FEMA 154 Rapid Visual Screening Score Card

Rapid Visual Screening - Senate Bill #2 - Seismic Needs Assessment
Oregon Department of Geology and Mineral Industries

TVF & R - Station 68 Oak Hills (Apparatus)

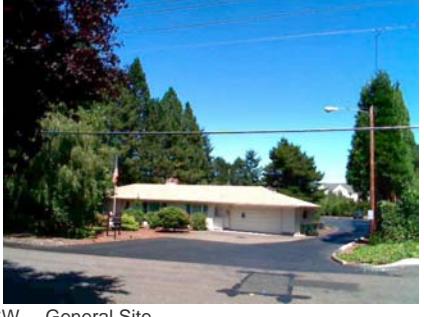
SW General Site		SE Falling Hazard

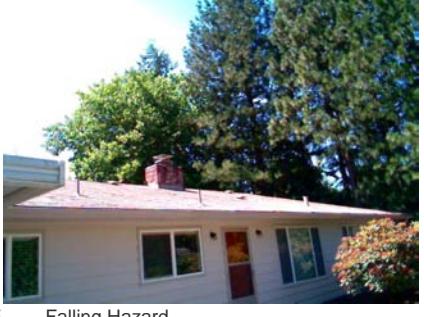
E Falling Hazard Short Chimney may not be considered a falling hazard

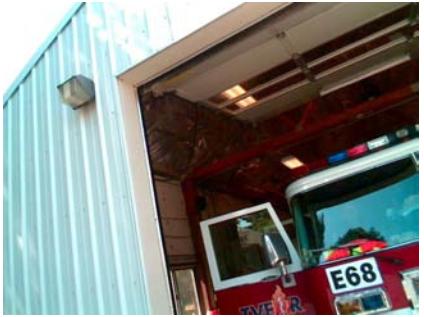
SE	Primary Structural Type
