TVF & R - Station 62 Command Center

Wash_fir15A

FEMA 154 Rapid Visual Screening Score Card

Rapid Visual Screening - Senate Bill #2 - Seismic Needs Assessment
Oregon Department of Geology and Mineral Industries

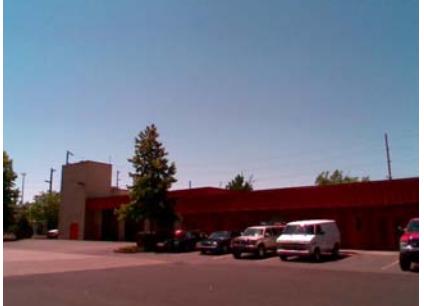
E Elevation View	E Vertical Irregularity Primary	E Plan Irregularity Secondary
