TVF & R - Station 62 Command Center

Wash_fir18A

FEMA 154 Rapid Visual Screening Score Card

Rapid Visual Screening - Senate Bill #2 - Seismic Needs Assessment
Oregon Department of Geology and Mineral Industries

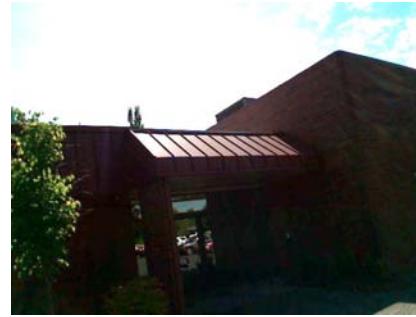
NW Vertical Irregularity Primary

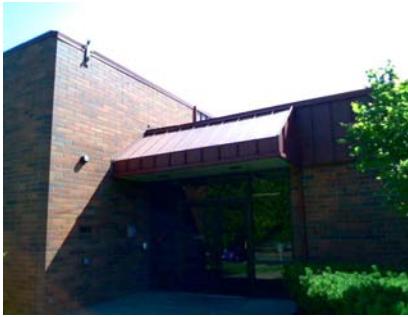
SW Falling Hazard

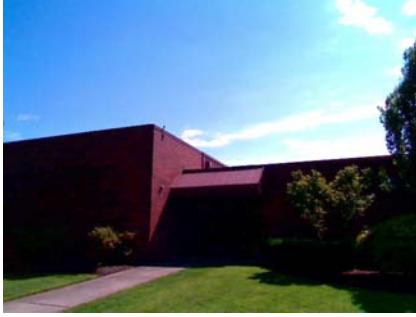
S Vertical Irregularity Primary

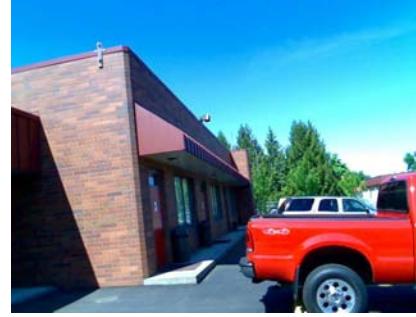
NE Falling Hazard

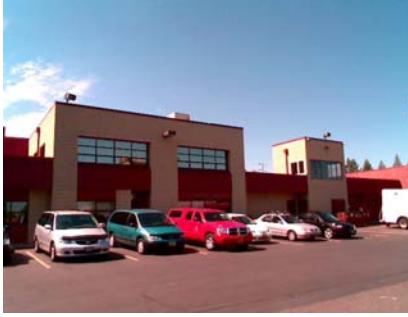
N Vertical Irregularity Primary

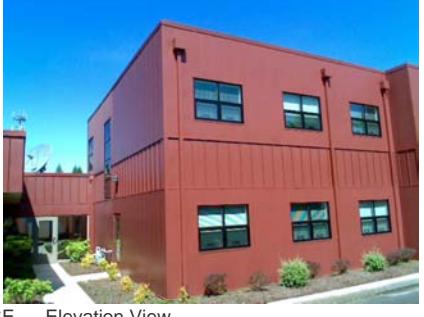
SE Elevation View S3 connects to RM1

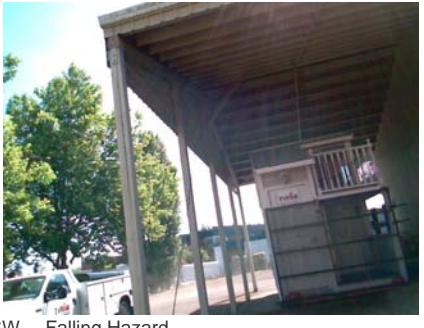
SW Falling Hazard
