Gaston RFPD

Wash_fir20A

| Tracking Code RVS in 2006 | Inspection Date 7/6/2006 | |

FEMA 154 Rapid Visual Screening Score Card

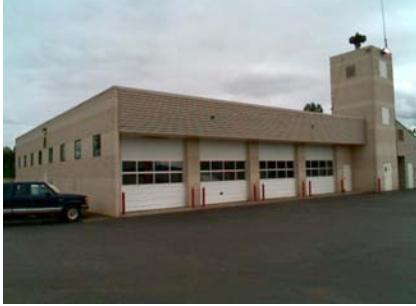
| S | General Site | SE | Primary Structural Type |

| Reentrant Corners:L shaped (Adjacent Build/Entity) | | Steps in Elevation View: Single Change | |
| Lateral-Force-Resistance in One Direction Only | | None | |

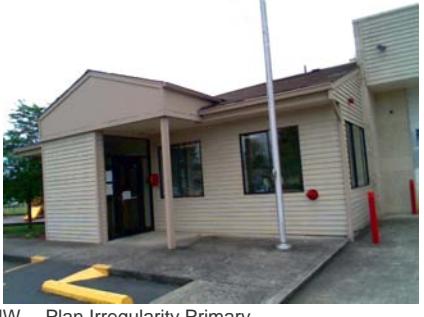
| NW Plan Irregularity Primary | | NE Elevation View | |

| Reentrant Corners:L shaped (Adjacent Build/Entity) | | None | |
