Washington County RFPD 2

Wash_fir24A

FEMA 154 Rapid Visual Screening Score Card

Rapid Visual Screening - Senate Bill #2 - Seismic Needs Assessment
Oregon Department of Geology and Mineral Industries

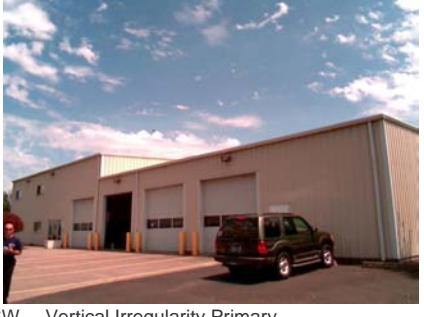
SW Vertical Irregularity Primary		SE Elevation View

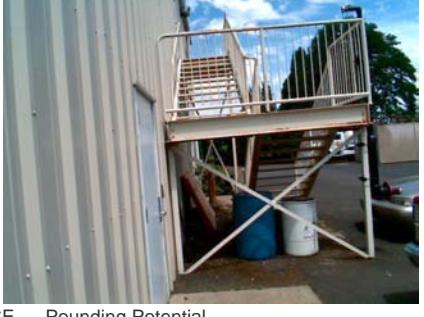
SE Pounding Potential
