Washington County RFPD 2

| 31370 Nw Commercial St | | |

FEMA 154 Rapid Visual Screening Score Card

Rapid Visual Screening - Senate Bill #2 - Seismic Needs Assessment
Oregon Department of Geology and Mineral Industries

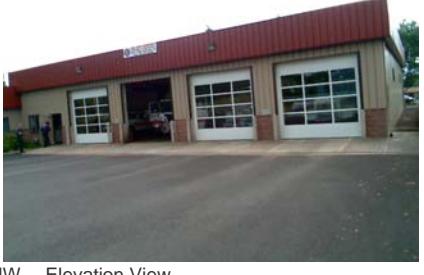
| NW Elevation View | NW Primary Structural Type front side of doors | SE Primary Structural Type steel w-flange column. | |

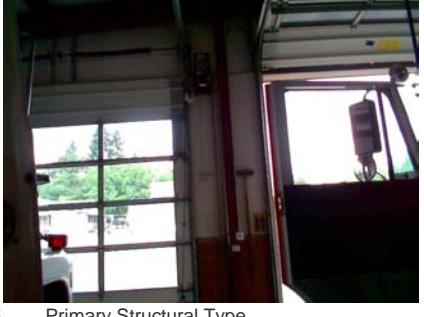
| S Primary Structural Type RM1 does not go to ceiling, and does not appear to connect to steel frame. | SE Primary Structural Type base of column | S Primary Structural Type | |

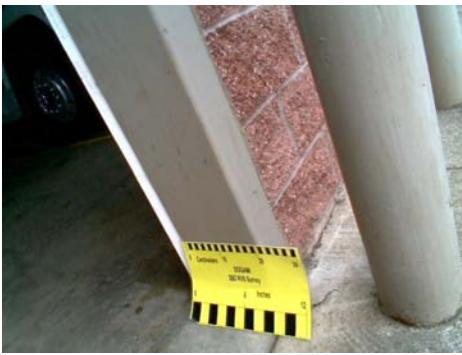
NE Secondary Structural Type
~1/8 thick U-channel frames garage doors. RM1 walls appear to only go up 4.5ft and don't appear to connect.

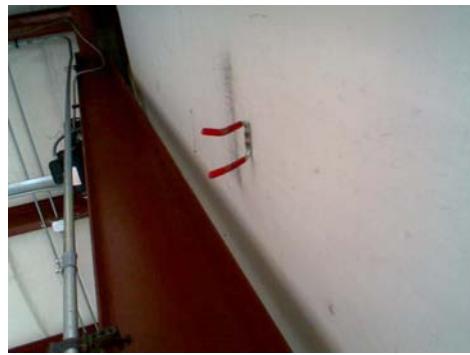
NE Primary Structural Type
steel column does not appear to tie in to the wall.
View is looking up the wall.
