Tuality Community Hospital - Hillsboro

Wash_hos01A

FEMA 154 Rapid Visual Screening Score Card

Rapid Visual Screening - Senate Bill #2 - Seismic Needs Assessment
Oregon Department of Geology and Mineral Industries

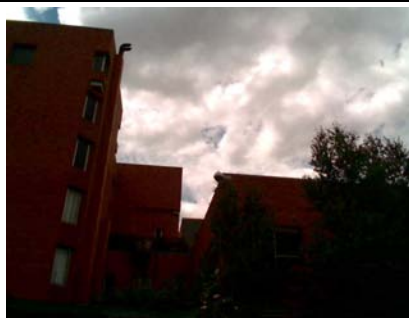
NE Vertical Irregularity Primary
6 stories on left side

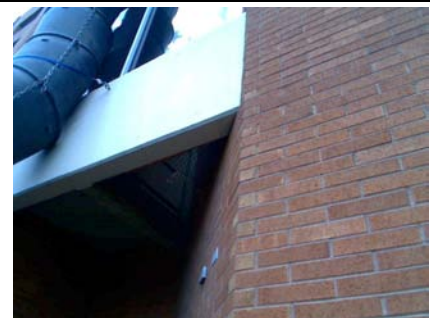
S Primary Structural Type
C2 under brick.

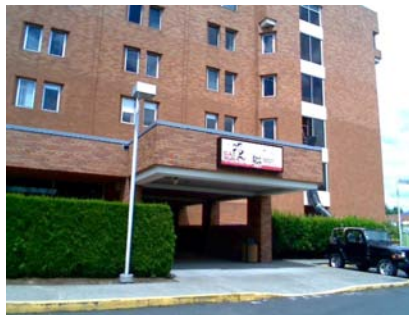
SE Falling Hazard
Heavy cantilevered covered walkway

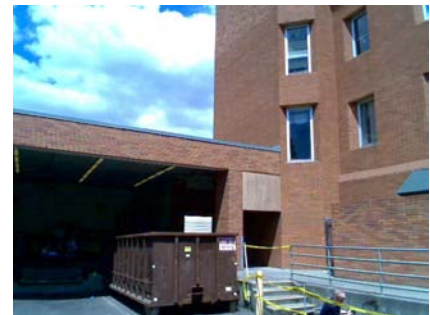
S Vertical Irregularity Primary

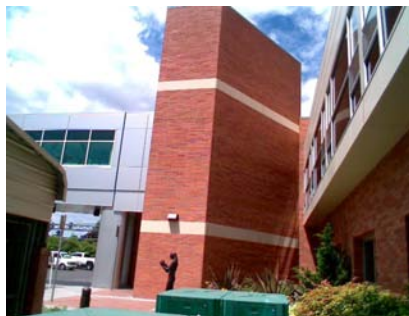
SE Plan Irregularity Primary

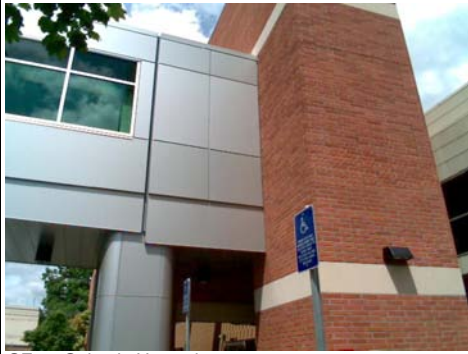
SE Seismic Upgrade
walkway to new bldg has 4" seismic joint.

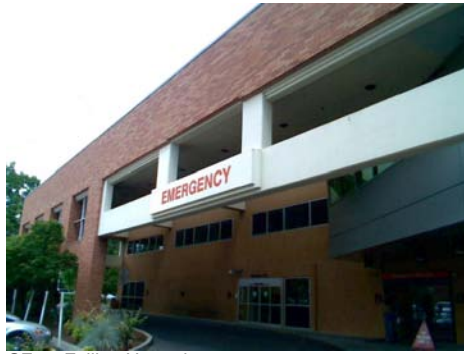
SE Falling Hazard
Concrete suspended beam

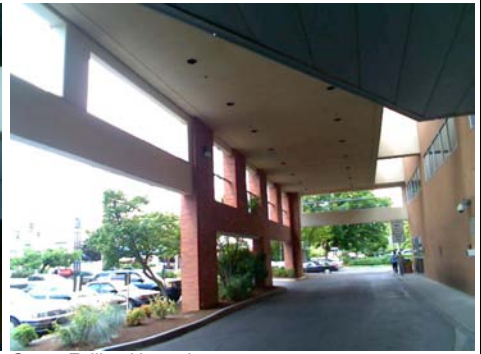
S Falling Hazard
