Providence St. Vincent Hospital

Wash_hos02A

FEMA 154 Rapid Visual Screening Score Card

Rapid Visual Screening - Senate Bill #2 - Seismic Needs Assessment
Oregon Department of Geology and Mineral Industries

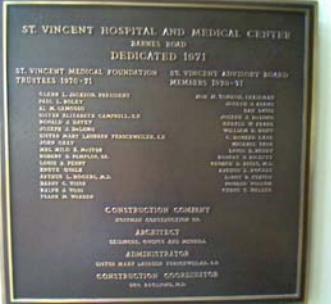
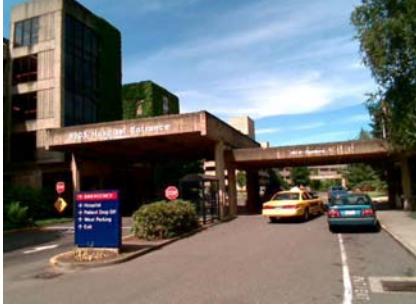
E Field Verified Year Built 1971		E Pounding Potential

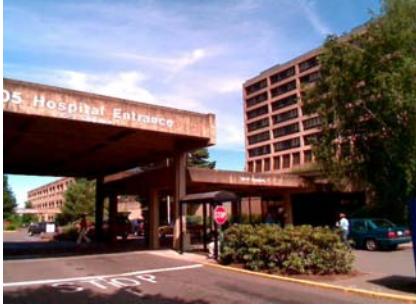
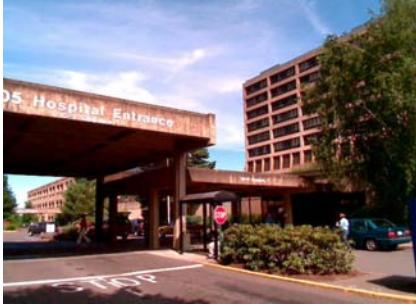
SE Pounding Potential over main ent

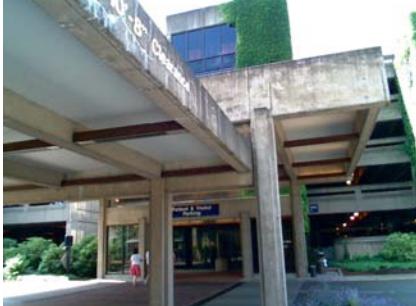
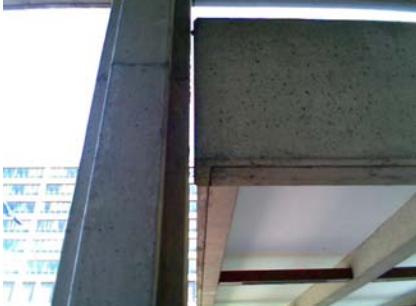
S Pounding Potential		S Pounding Potential out of plain elements are separated by ~1".

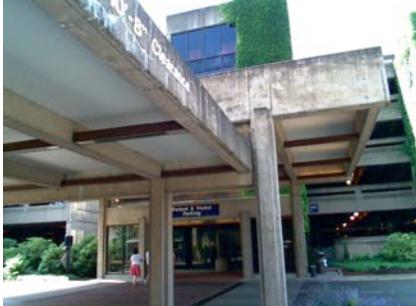
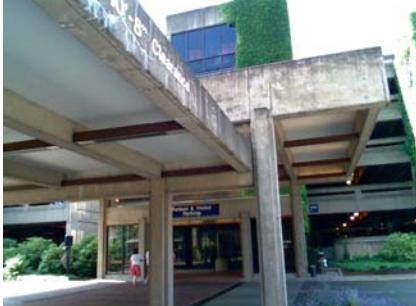
NW Pounding Potential

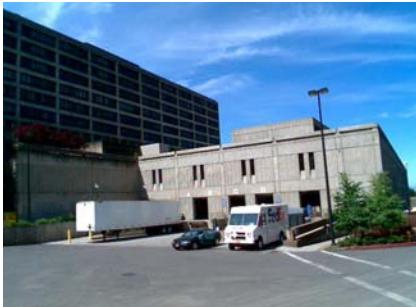
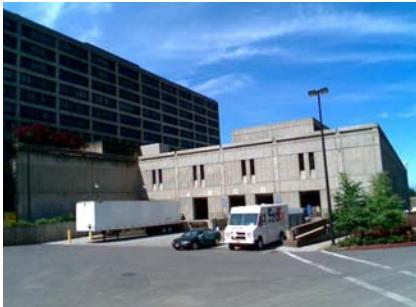
NE Elevation View new const on the right edge of pic.		E Elevation View Mech building and loading dock, not RVsed

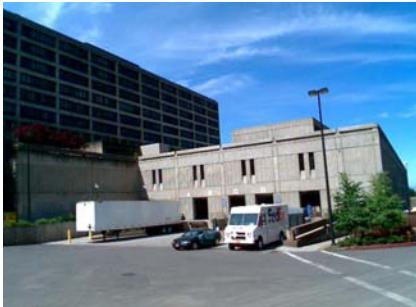
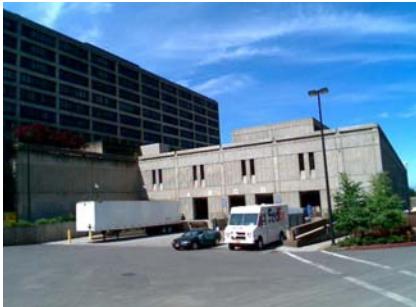
NE Elevation View Bldg A is in upper left of photo

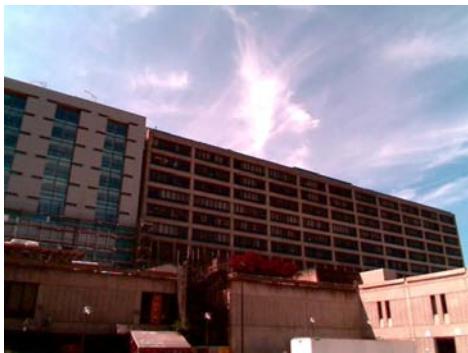
N General Site

New construction 2004 on left side of photo.

Mech bldg in foreground

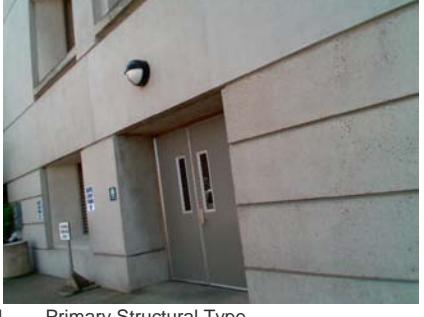
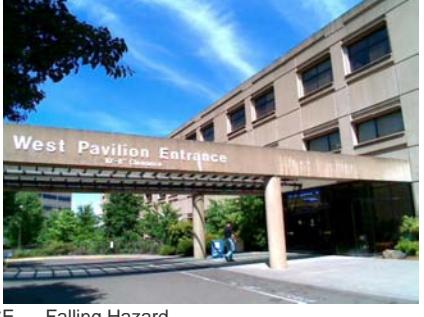
N	Primary Structural Type	SE	Falling Hazard
