Gaston Police Dept

Wash_pol11A

FEMA 154 Rapid Visual Screening Score Card

Rapid Visual Screening - Senate Bill #2 - Seismic Needs Assessment
Oregon Department of Geology and Mineral Industries

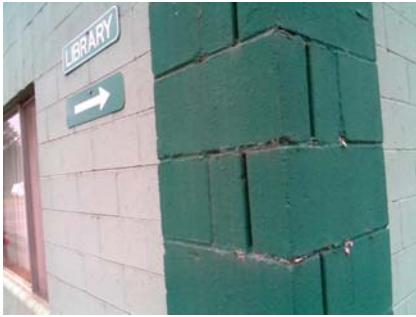
NW Primary Structural Type

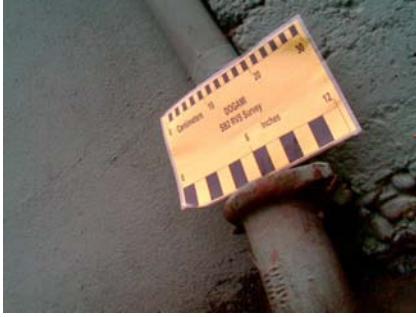
NE Poor Condition
very worn C2 wall against RM1.

Bad photo, there is a C2 wall on the right side of the photo with

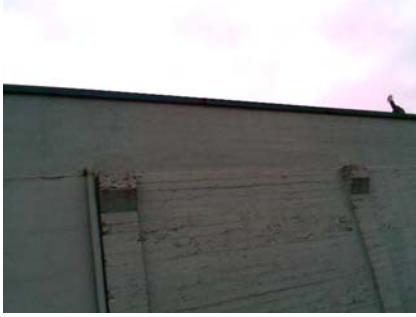
N Falling Hazard
