# Mooberry Elementary School

Wash\_sch05A

## FEMA 154 Rapid Visual Screening Score Card

Rapid Visual Screening - Senate Bill #2 - Seismic Needs Assessment  
Oregon Department of Geology and Mineral Industries

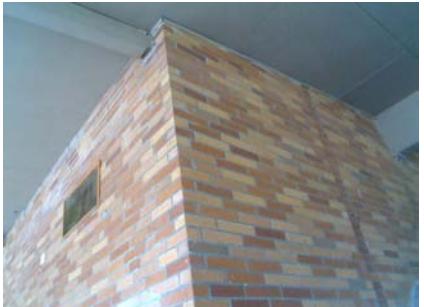
S Building Name	W General Site	SW Falling Hazard

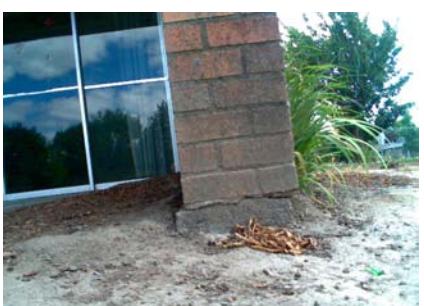
NW General Site	NW Poor Condition Wall sliding off foundation	N Poor Condition full view of last photo

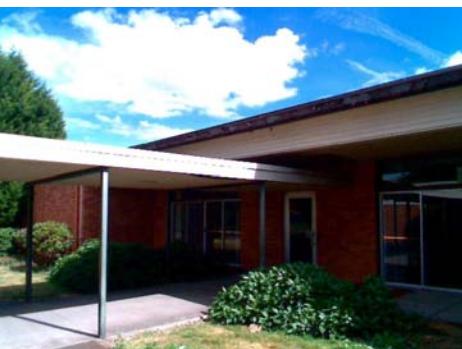
NE Pounding Potential

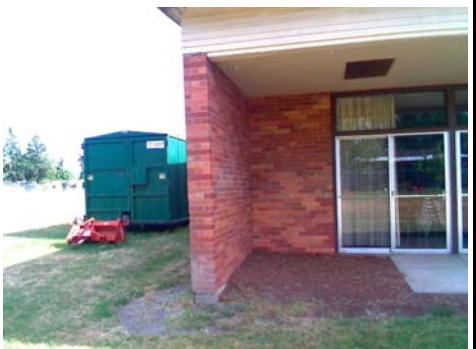
N Poor Condition

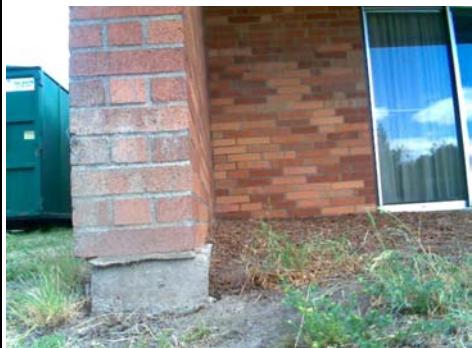
NW Poor Condition  
Other wall sliding off foundation

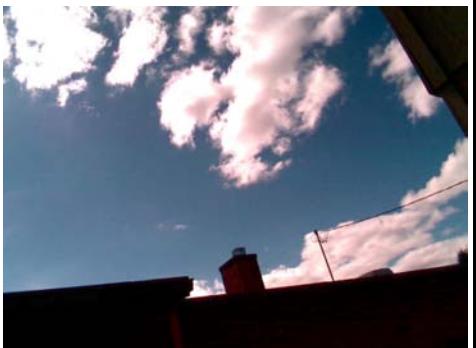
E Falling Hazard
