Banks High School

FEMA 154 Rapid Visual Screening Score Card

Rapid Visual Screening - Senate Bill #2 - Seismic Needs Assessment
Oregon Department of Geology and Mineral Industries

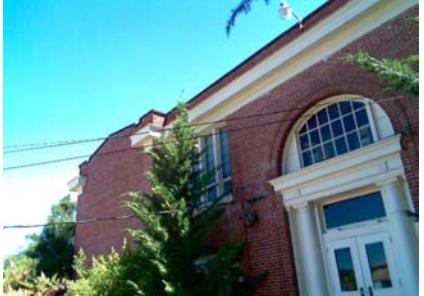
SW Falling Hazard Heavy Cornice

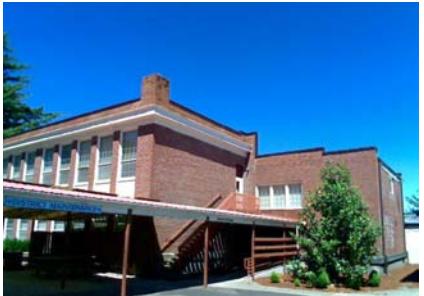
S Falling Hazard

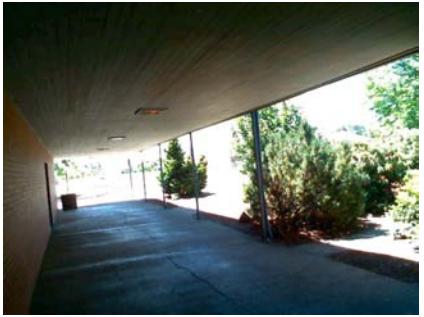
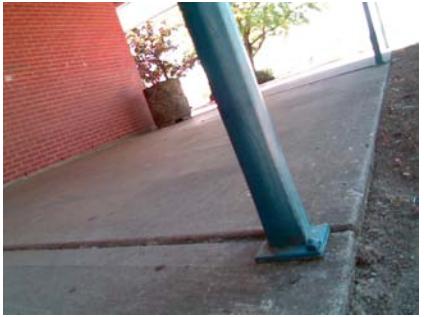
N Falling Hazard Weak columns	NW Falling Hazard columns held to concrete with two bolts. Box tubing is rounded at base (damage) most likely due to freezing water in the column expanding. Several other	W Falling Hazard

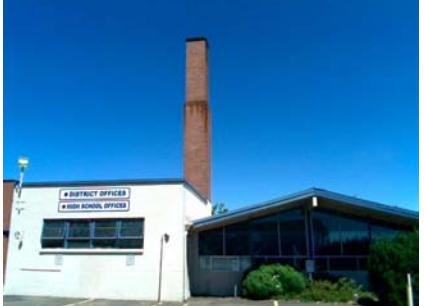
W General Site	SE Falling Hazard C2 mech room on left not RVsed. Bldg E on right side.	SW General Site

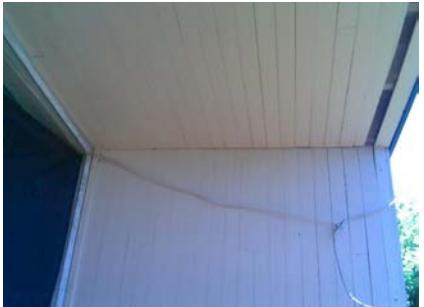
SW Primary Structural Type Wood siding all around.	NE Falling Hazard

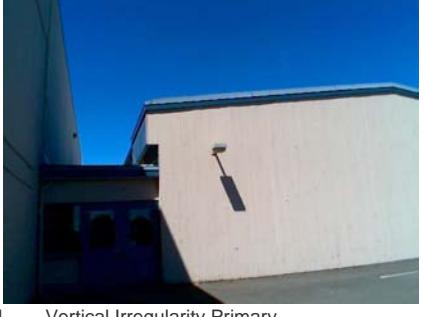
N Vertical Irregularity Primary
