Groner Elementary School

Hillsboro SD 1J

FEMA 154 Rapid Visual Screening Score Card

Rapid Visual Screening - Senate Bill #2 - Seismic Needs Assessment
Oregon Department of Geology and Mineral Industries

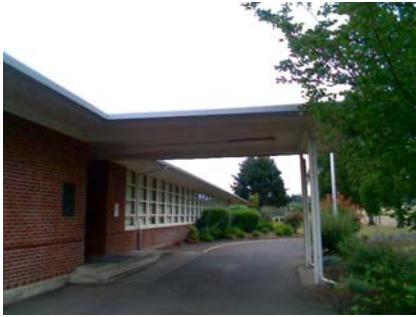
SE Falling Hazard

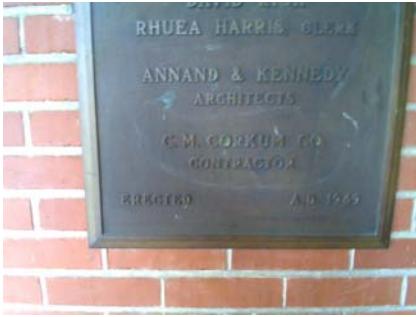
N Field Verified Year Built 1949

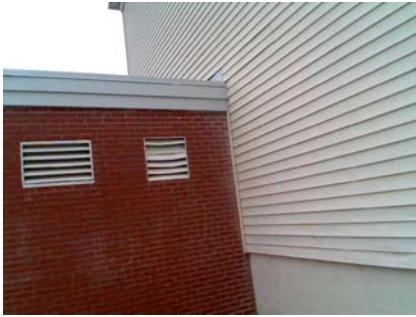
SW Plan Irregularity Primary	W Basement	SW General Site

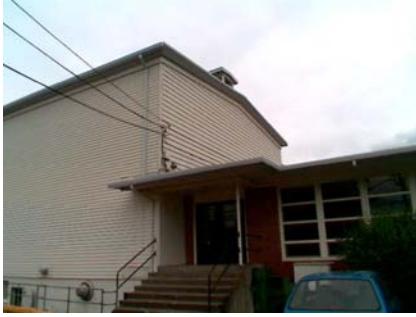
S Vertical Irregularity Primary	NE Falling Hazard There is a Chimney in there, right of the bell.	N Falling Hazard

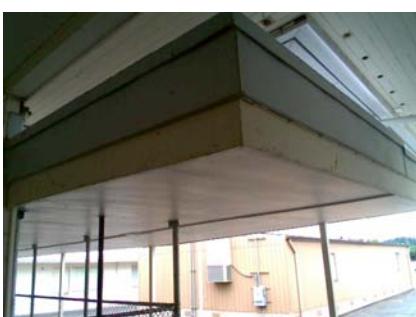
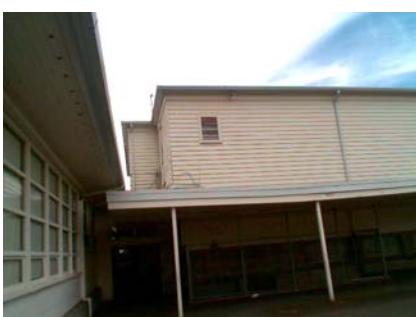
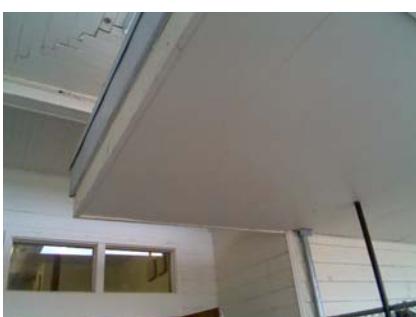
SE Falling Hazard covered walkway, 6 foot cantilevered. roof shows ~8" of sag on side nearest school door	NW Falling Hazard covered walkway, 6 foot cantilevered. roof shows ~8" of sag on side nearest school door	N Falling Hazard covered walkway, 6 foot cantilevered. roof shows ~8" of sag on side nearest school door

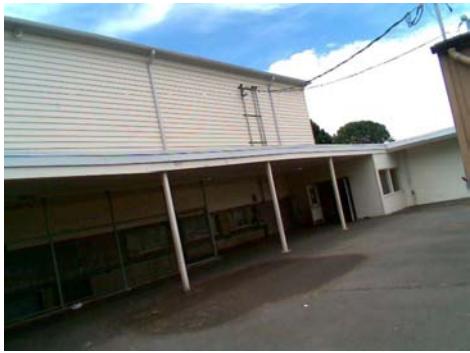
N Falling Hazard
