Brookwood Elementary School

Hillsboro SD 1J

FEMA 154 Rapid Visual Screening Score Card

Rapid Visual Screening - Senate Bill #2 - Seismic Needs Assessment
Oregon Department of Geology and Mineral Industries

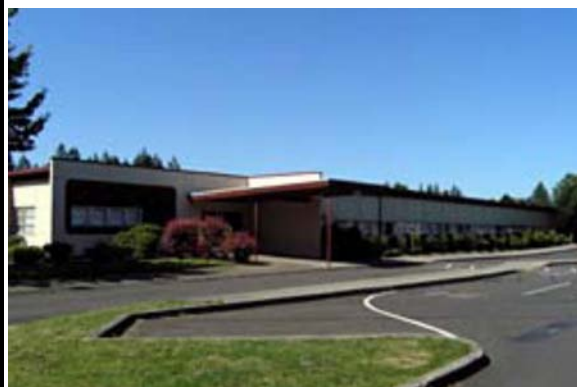
Type	Basic Score	Vert Irreg	Plan Irreg	Pre-Code	Post-Bench	Soil C	Soil D	Soil E	RVS Score
Primary	C2	2.8	-1	-0.5	0	0	0	-0.6	0	0.7
Secondary		0	0	0	0	0	0	0	0	0
Tertiary		0	0	0	0	0	0	0	0	0

0.7

High (>10%)
