Harvey Clarke Elementary School

Forest Grove SD 15

FEMA 154 Rapid Visual Screening Score Card

Rapid Visual Screening - Senate Bill #2 - Seismic Needs Assessment
Oregon Department of Geology and Mineral Industries

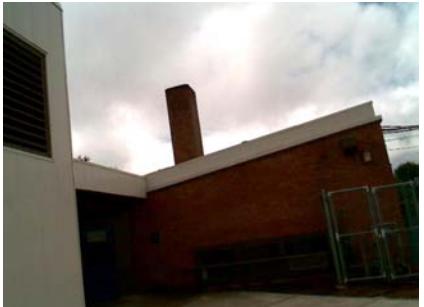
N General Site	NE Falling Hazard	W General Site

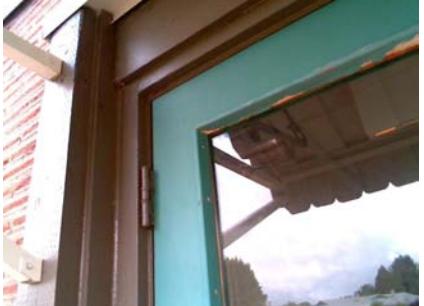
NW General Site	W Primary Structural Type Wood	W General Site

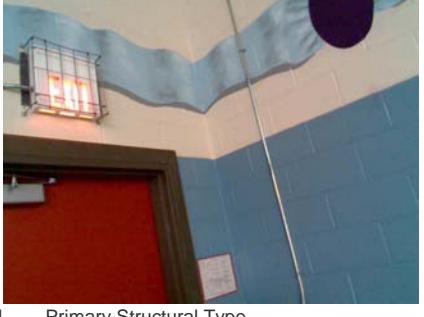
N Primary Structural Type

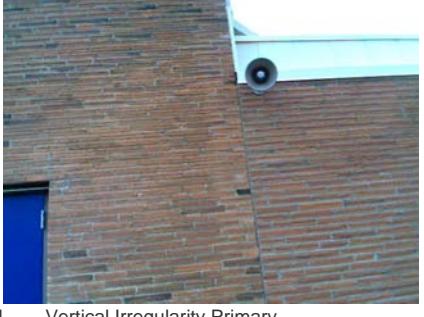
N Vertical Irregularity Primary

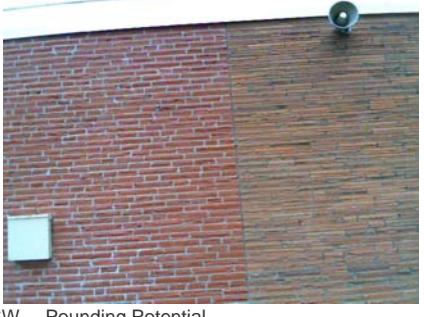
<p>SW Pounding Potential</p>
