Bridgeport Elementary School

Wash_sch28A

FEMA 154 Rapid Visual Screening Score Card

Rapid Visual Screening - Senate Bill #2 - Seismic Needs Assessment
Oregon Department of Geology and Mineral Industries

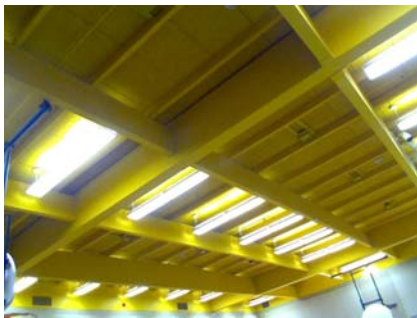
NW Primary Structural Type
W2

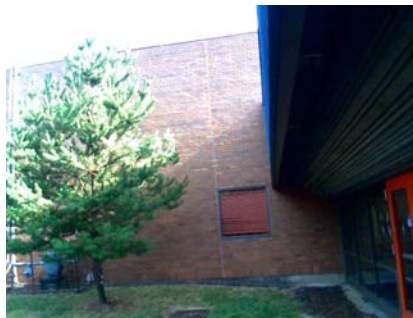
SW Plan Irregularity Primary

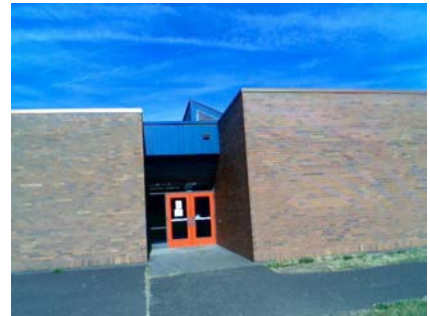
NE Pounding Potential

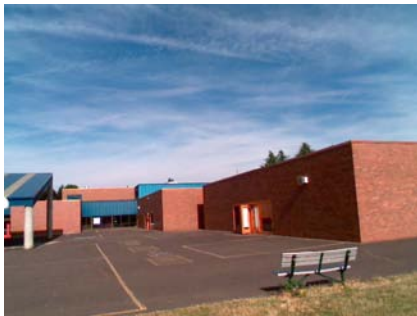
E Plan Irregularity Primary

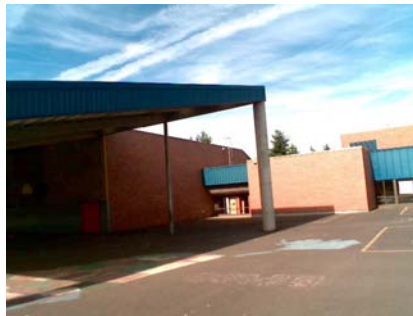
N Pounding Potential

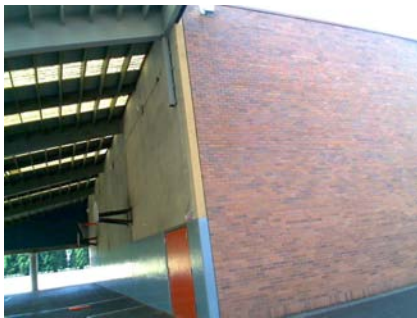
NW Plan Irregularity Primary
confirmed W2 with brick veneer on right. Tilt upon left.

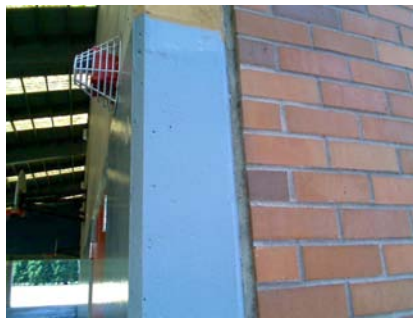
N Primary Structural Type

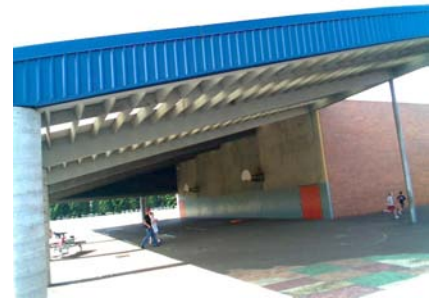
NE General Site
covered play area not RVSeD
