Durham Elementary School

Tigard-Tualatin SD 23J

FEMA 154 Rapid Visual Screening Score Card

Rapid Visual Screening - Senate Bill #2 - Seismic Needs Assessment
Oregon Department of Geology and Mineral Industries

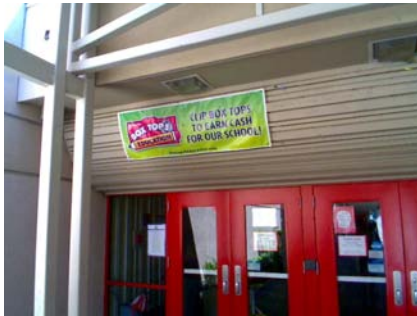
SW Falling Hazard
wooden overhangs in between bldgs

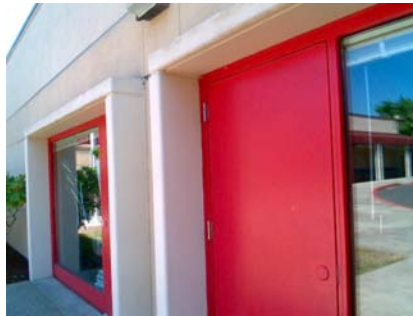
N Falling Hazard
Precast Concrete over doorways

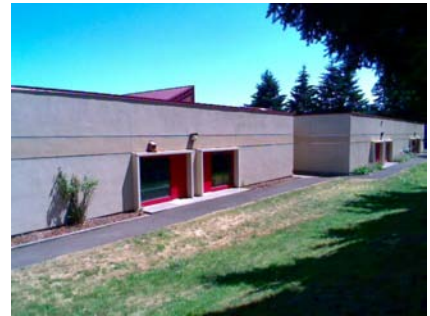
NW Plan Irregularity Primary

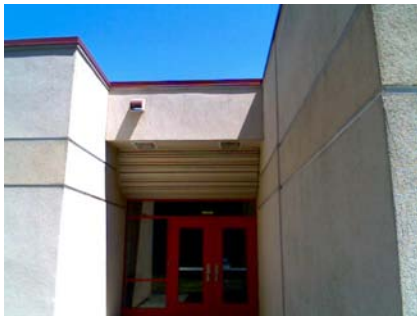
NW Pounding Potential
there are a few doorways like this one.

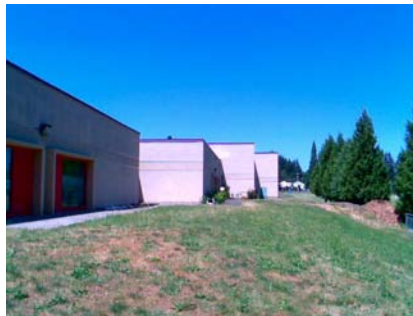
E Plan Irregularity Primary

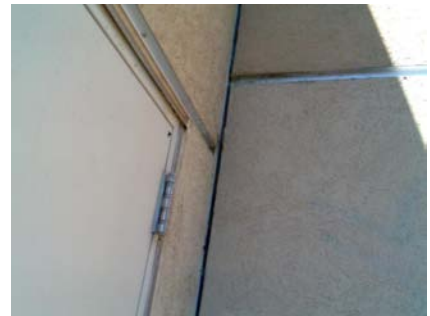
SE Primary Structural Type
wood member can be seen in crack behind panel.

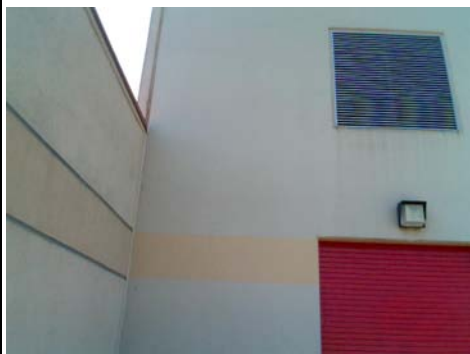
NE Pounding Potential
Bldg A and B

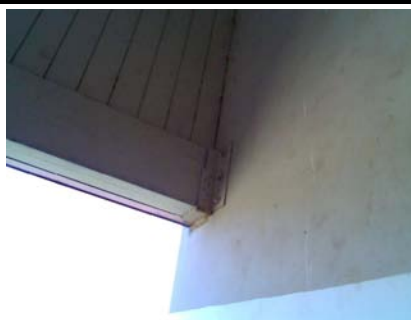
NE Falling Hazard
weak connection to covered play area.
6 nails visble
