Farmington View Elementary School

Wash_sch75A

FEMA 154 Rapid Visual Screening Score Card

Rapid Visual Screening - Senate Bill #2 - Seismic Needs Assessment
Oregon Department of Geology and Mineral Industries

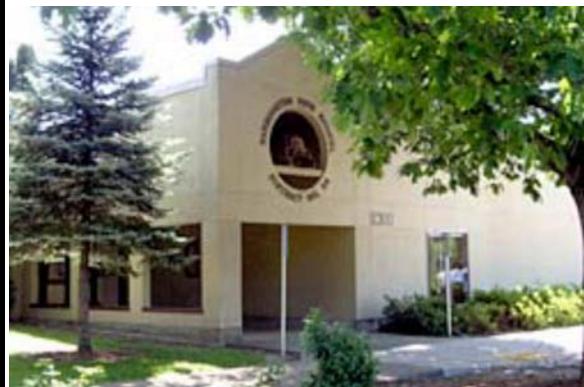
Type	Basic Score	Vert Irreg	Plan Irreg	Pre-Code	Post-Bench	Soil C	Soil D	Soil E	RVS Score
Primary	C2	2.8	-1	-0.5	0	0	-0.4	0	0	0.9
Secondary		0	0	0	0	0	0	0	0	0
Tertiary		0	0	0	0	0	0	0	0	0

Final Type	Final Score
C2	0.9

Moderate (>1%)

Enrollment 226	Year Built (Field Verified) 1949	Year Built (Alt. Source) 1949	Est. Decade Built
Total Area (square ft) 20467	Number of Stories 1	Basement	Pounding Potential No
Plan Irregularities		Vertical Irregularities	
Falling Hazards		Poor Conditions
