Sherwood Middle School

Sherwood SD 88J

FEMA 154 Rapid Visual Screening Score Card

Rapid Visual Screening - Senate Bill #2 - Seismic Needs Assessment
Oregon Department of Geology and Mineral Industries

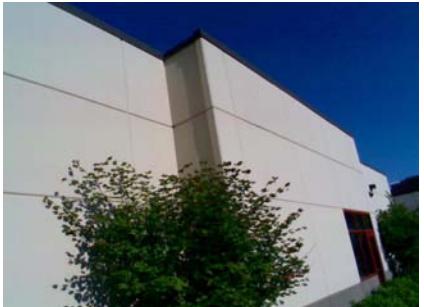
SW Plan Irregularity Primary

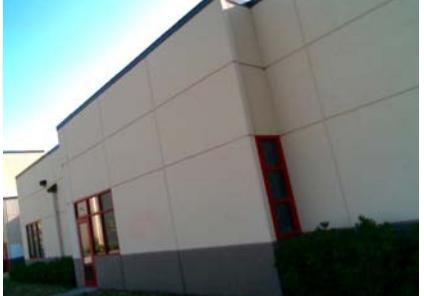
NE Plan Irregularity Primary

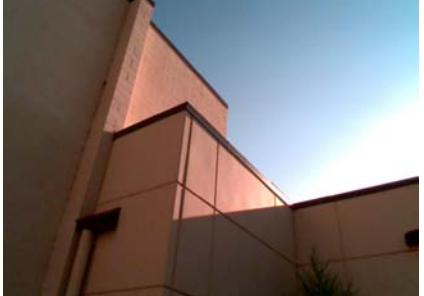
NE Pounding Potential

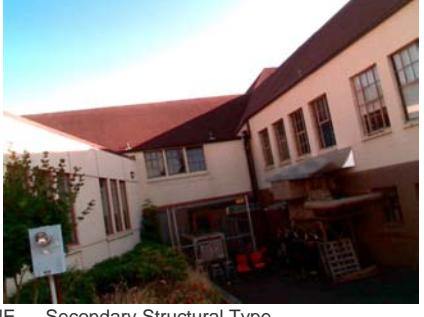
NE Secondary Structural Type RM1 on E. wall

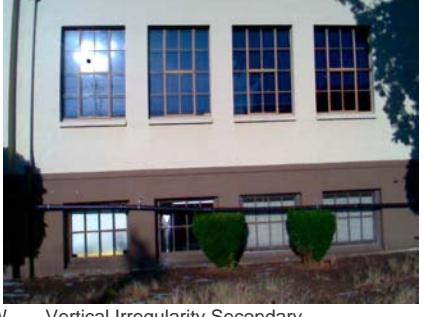
W Vertical Irregularity Secondary short columns ??

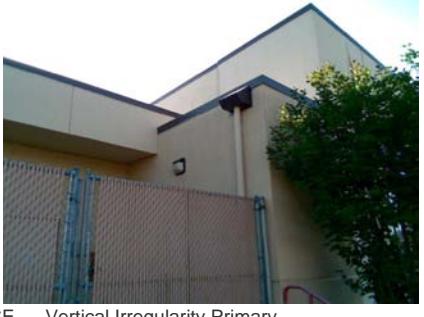
SE Vertical Irregularity Primary

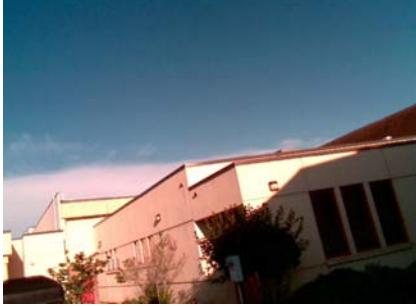
W	Plan Irregularity Secondary

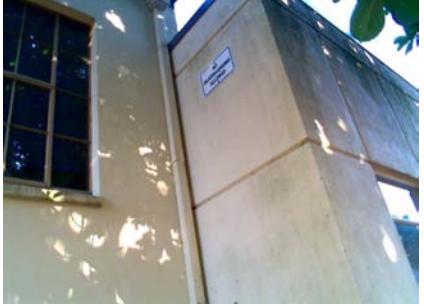
NW Pounding Potential

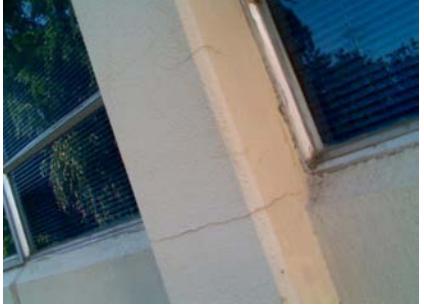
SE Poor Condition each column shows cracks at base of windo level
