Gaston Elementary School

Gaston SD 511J

Wash_sch80A

Rapid Visual Screening - Senate Bill #2 - Seismic Needs Assessment
Oregon Department of Geology and Mineral Industries

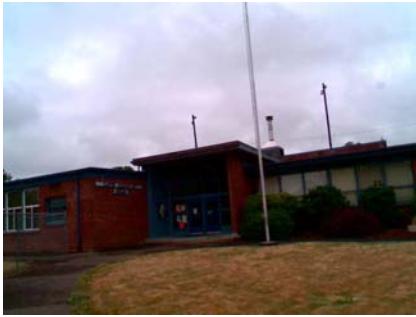
N Building Name		NE Elevation View

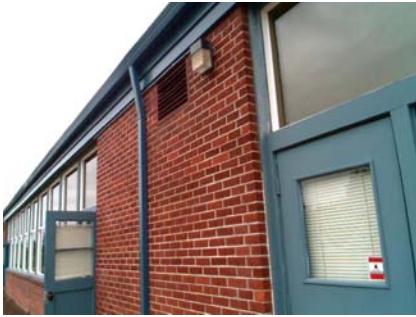
Enrollment 232	Year Built (Field Verified) 1951	Year Built (Alt. Source) 1951	Est. Decade Built 1950
Total Area (square ft) 28820	Number of Stories 1	Basement	Pounding Potential No
Plan Irregularities Reentrant Corners:Other (Adjacent Build/Entity)		Vertical Irregularities Steps in Elevation View: 2 to 3 Changes	
Reentrant Corners: Other (Adjacent Build/Entity) None		Steps in Elevation View: Single Change (Adjacent Building/Entity) None	
Falling Hazards Other: Brick Veneer		Poor Conditions None	
None		None	
None		None

NE Falling Hazard

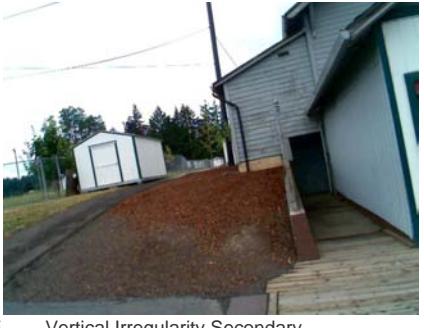
E Vertical Irregularity Secondary
