Carlton Fire Department

Yamh_fir04A

FEMA 154 Rapid Visual Screening Score Card

Rapid Visual Screening - Senate Bill #2 - Seismic Needs Assessment
Oregon Department of Geology and Mineral Industries

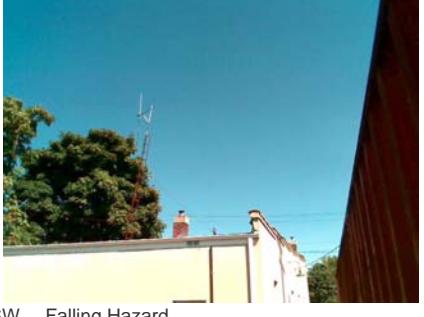
Enrollment	Year Built (Field Verified)	Year Built (Alt. Source)	Est. Decade Built
			1930
Total Area (square ft)	Number of Stories	Basement	Pounding Potential
	1	No	No
Plan Irregularities		Vertical Irregularities	
Torsion: Eccentric Stiffness		None	
None		None	
None		None	
Falling Hazards		Poor Conditions	
Unreinforced Chimneys		None	
Other: Brick Veneer		None	
Parapets: Unreinforced Around Entire Building		None

SW Elevation View		SW Falling Hazard
