Dundee Fire & Rescue

Yamh_fir07A

FEMA 154 Rapid Visual Screening Score Card

Rapid Visual Screening - Senate Bill #2 - Seismic Needs Assessment
Oregon Department of Geology and Mineral Industries

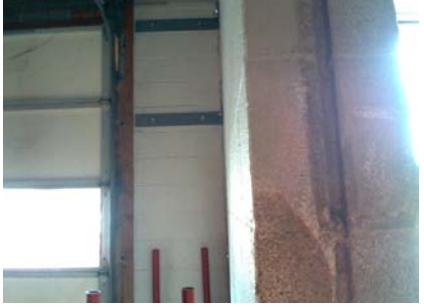
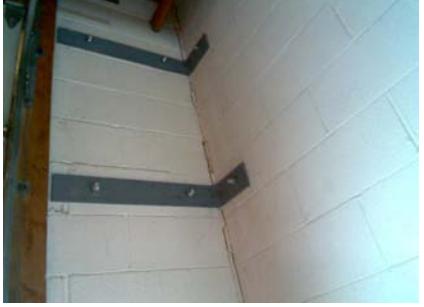
E	Poor Condition	SE	Poor Condition
<p>light is showing through the edge of the RM1 wall just to the right of the door.</p>		<p>Straps were added later to keep the wall on the left from moving farther away from the wall on the right.</p>

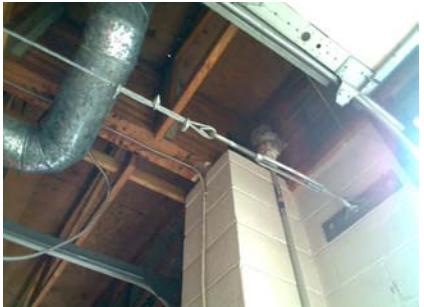
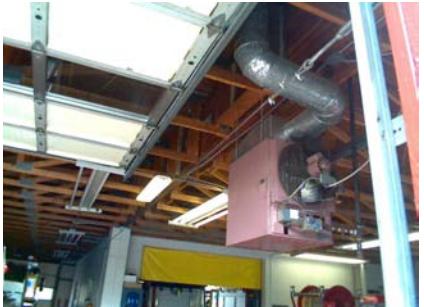
SE	Poor Condition	SE	Poor Condition
<p>See cable, Turnbuckle at top right corner of picture.</p>		<p>See cable, Turnbuckle at top right corner of picture.</p>

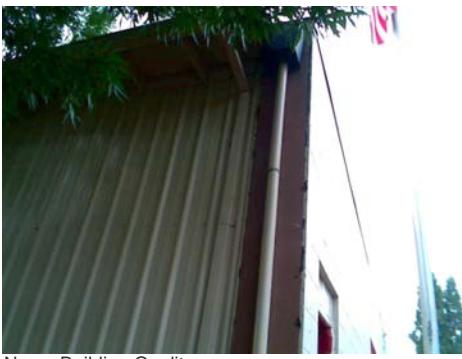
N Building Quality

There is a steel plate behind the drain pipe that covers a gap where the RM1 wall on the right has p

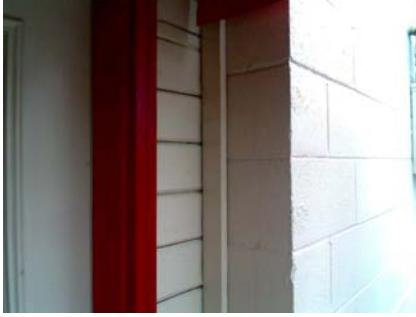
W	Elevation View	N	Falling Hazard RM1 wall infront of bldg
