Dayton High School

Yamh_sch01A

FEMA 154 Rapid Visual Screening Score Card

Rapid Visual Screening - Senate Bill #2 - Seismic Needs Assessment
Oregon Department of Geology and Mineral Industries

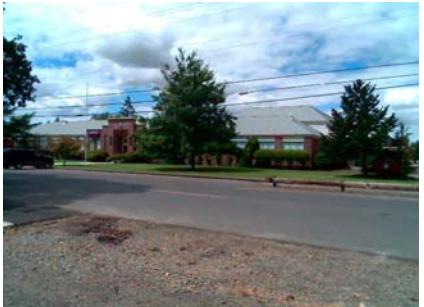
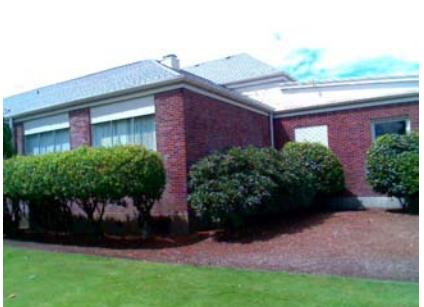
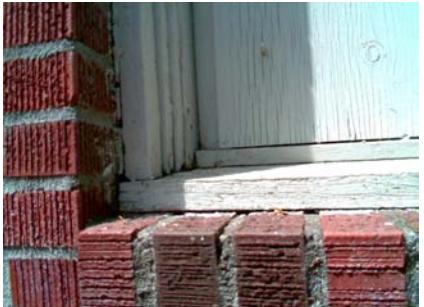
SE General Site	E Plan Irregularity Primary	NE Building Quality

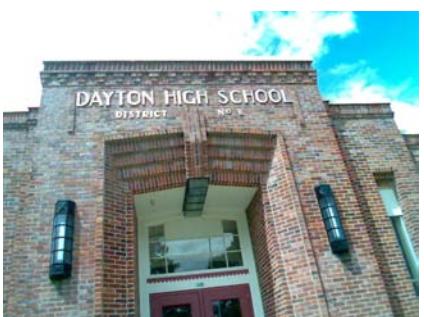
SE Falling Hazard	W Elevation View	N Elevation View

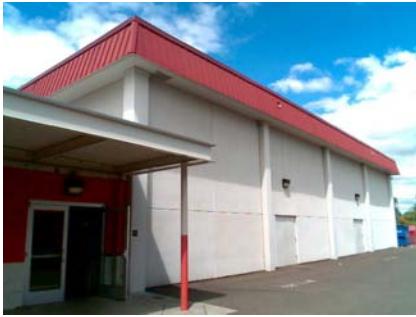
SE Vertical Irregularity Primary New bldg on left

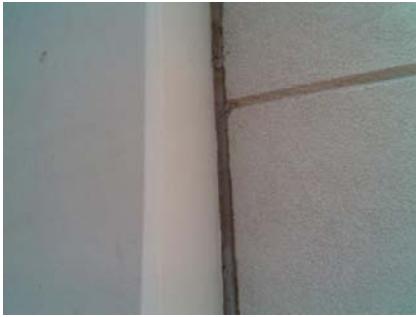
SE Primary Structural Type PC1

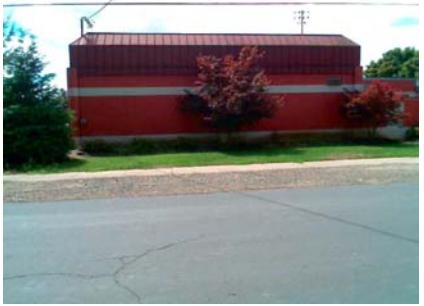
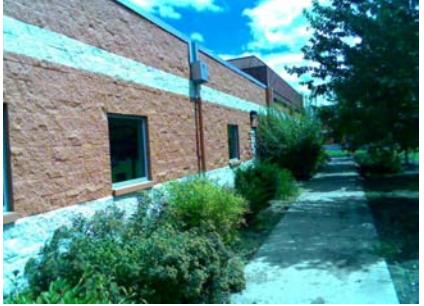
N Elevation View		W Elevation View new on left	S Elevation View

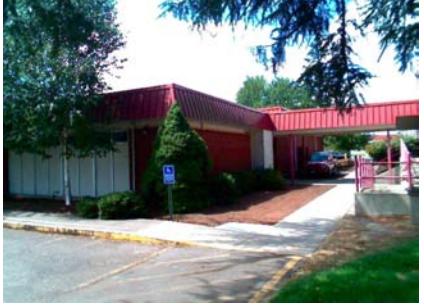
E Pounding Potential Covered walk way on right.		NW Elevation View
