# Carlton Elementary School

Yamh\_sch02A

## FEMA 154 Rapid Visual Screening Score Card

Rapid Visual Screening - Senate Bill #2 - Seismic Needs Assessment  
Oregon Department of Geology and Mineral Industries

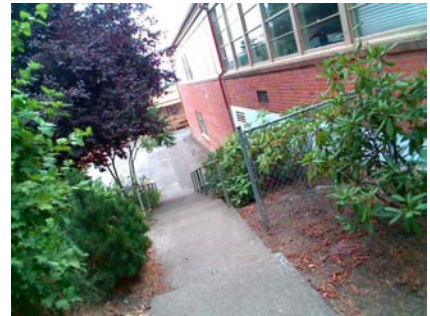
NW Vertical Irregularity Secondary  
Built on hill

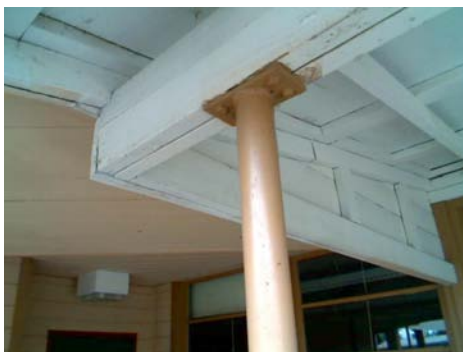
| Other: Brick Veneer | None |

NE Falling Hazard

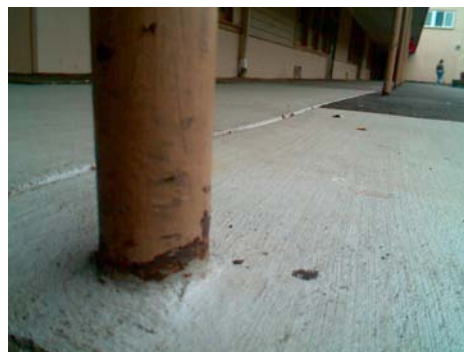
SE Falling Hazard

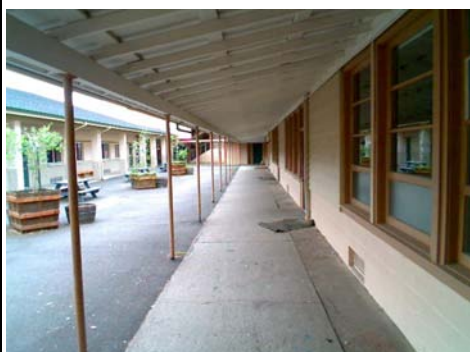
N Falling Hazard

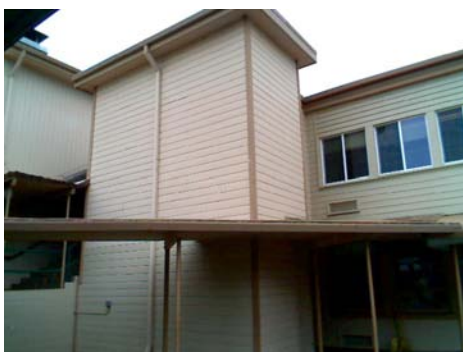
| Reentrant Corners: Other | Steps in Elevation View: Single Change (Adjacent Building/Entity) |
| Reentrant Corners: Other (Adjacent Build/Entity) | Building On Hill or Sloped Site |

N Plan Irregularity Primary

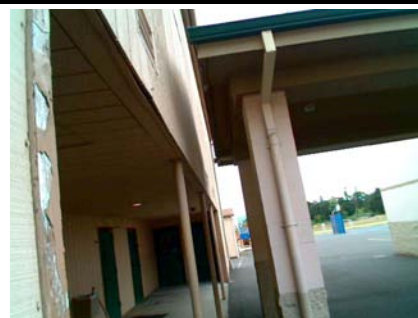
W Building Quality  
12" gap no pounding p.

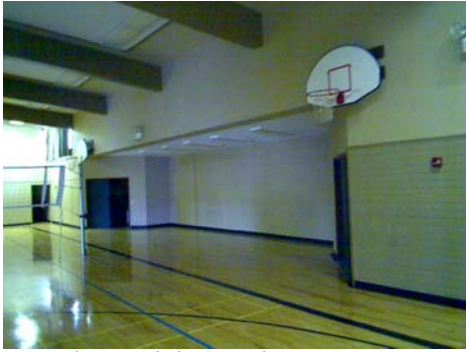
| Reentrant Corners: Other (Adjacent Build/Entity) | Steps in Elevation View: Single Change |

NW Plan Irregularity Secondary

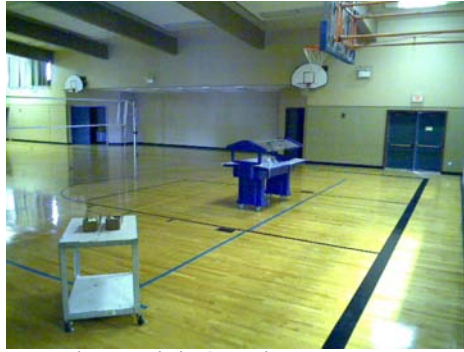
NW Plan Irregularity Secondary

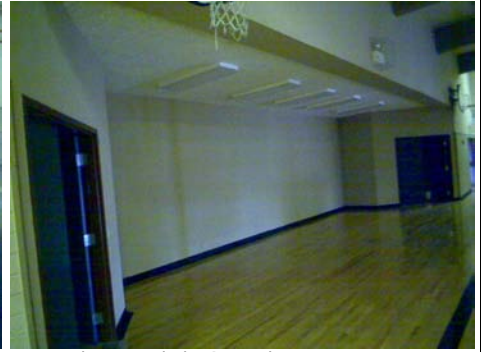
NE Plan Irregularity Secondary
